Vegetation Assessment Report –
Lots 1, 101 and Part Lot 3

COOLBELLUP HOTEL REDEVELOPMENT

Existing Vegetation Assessment

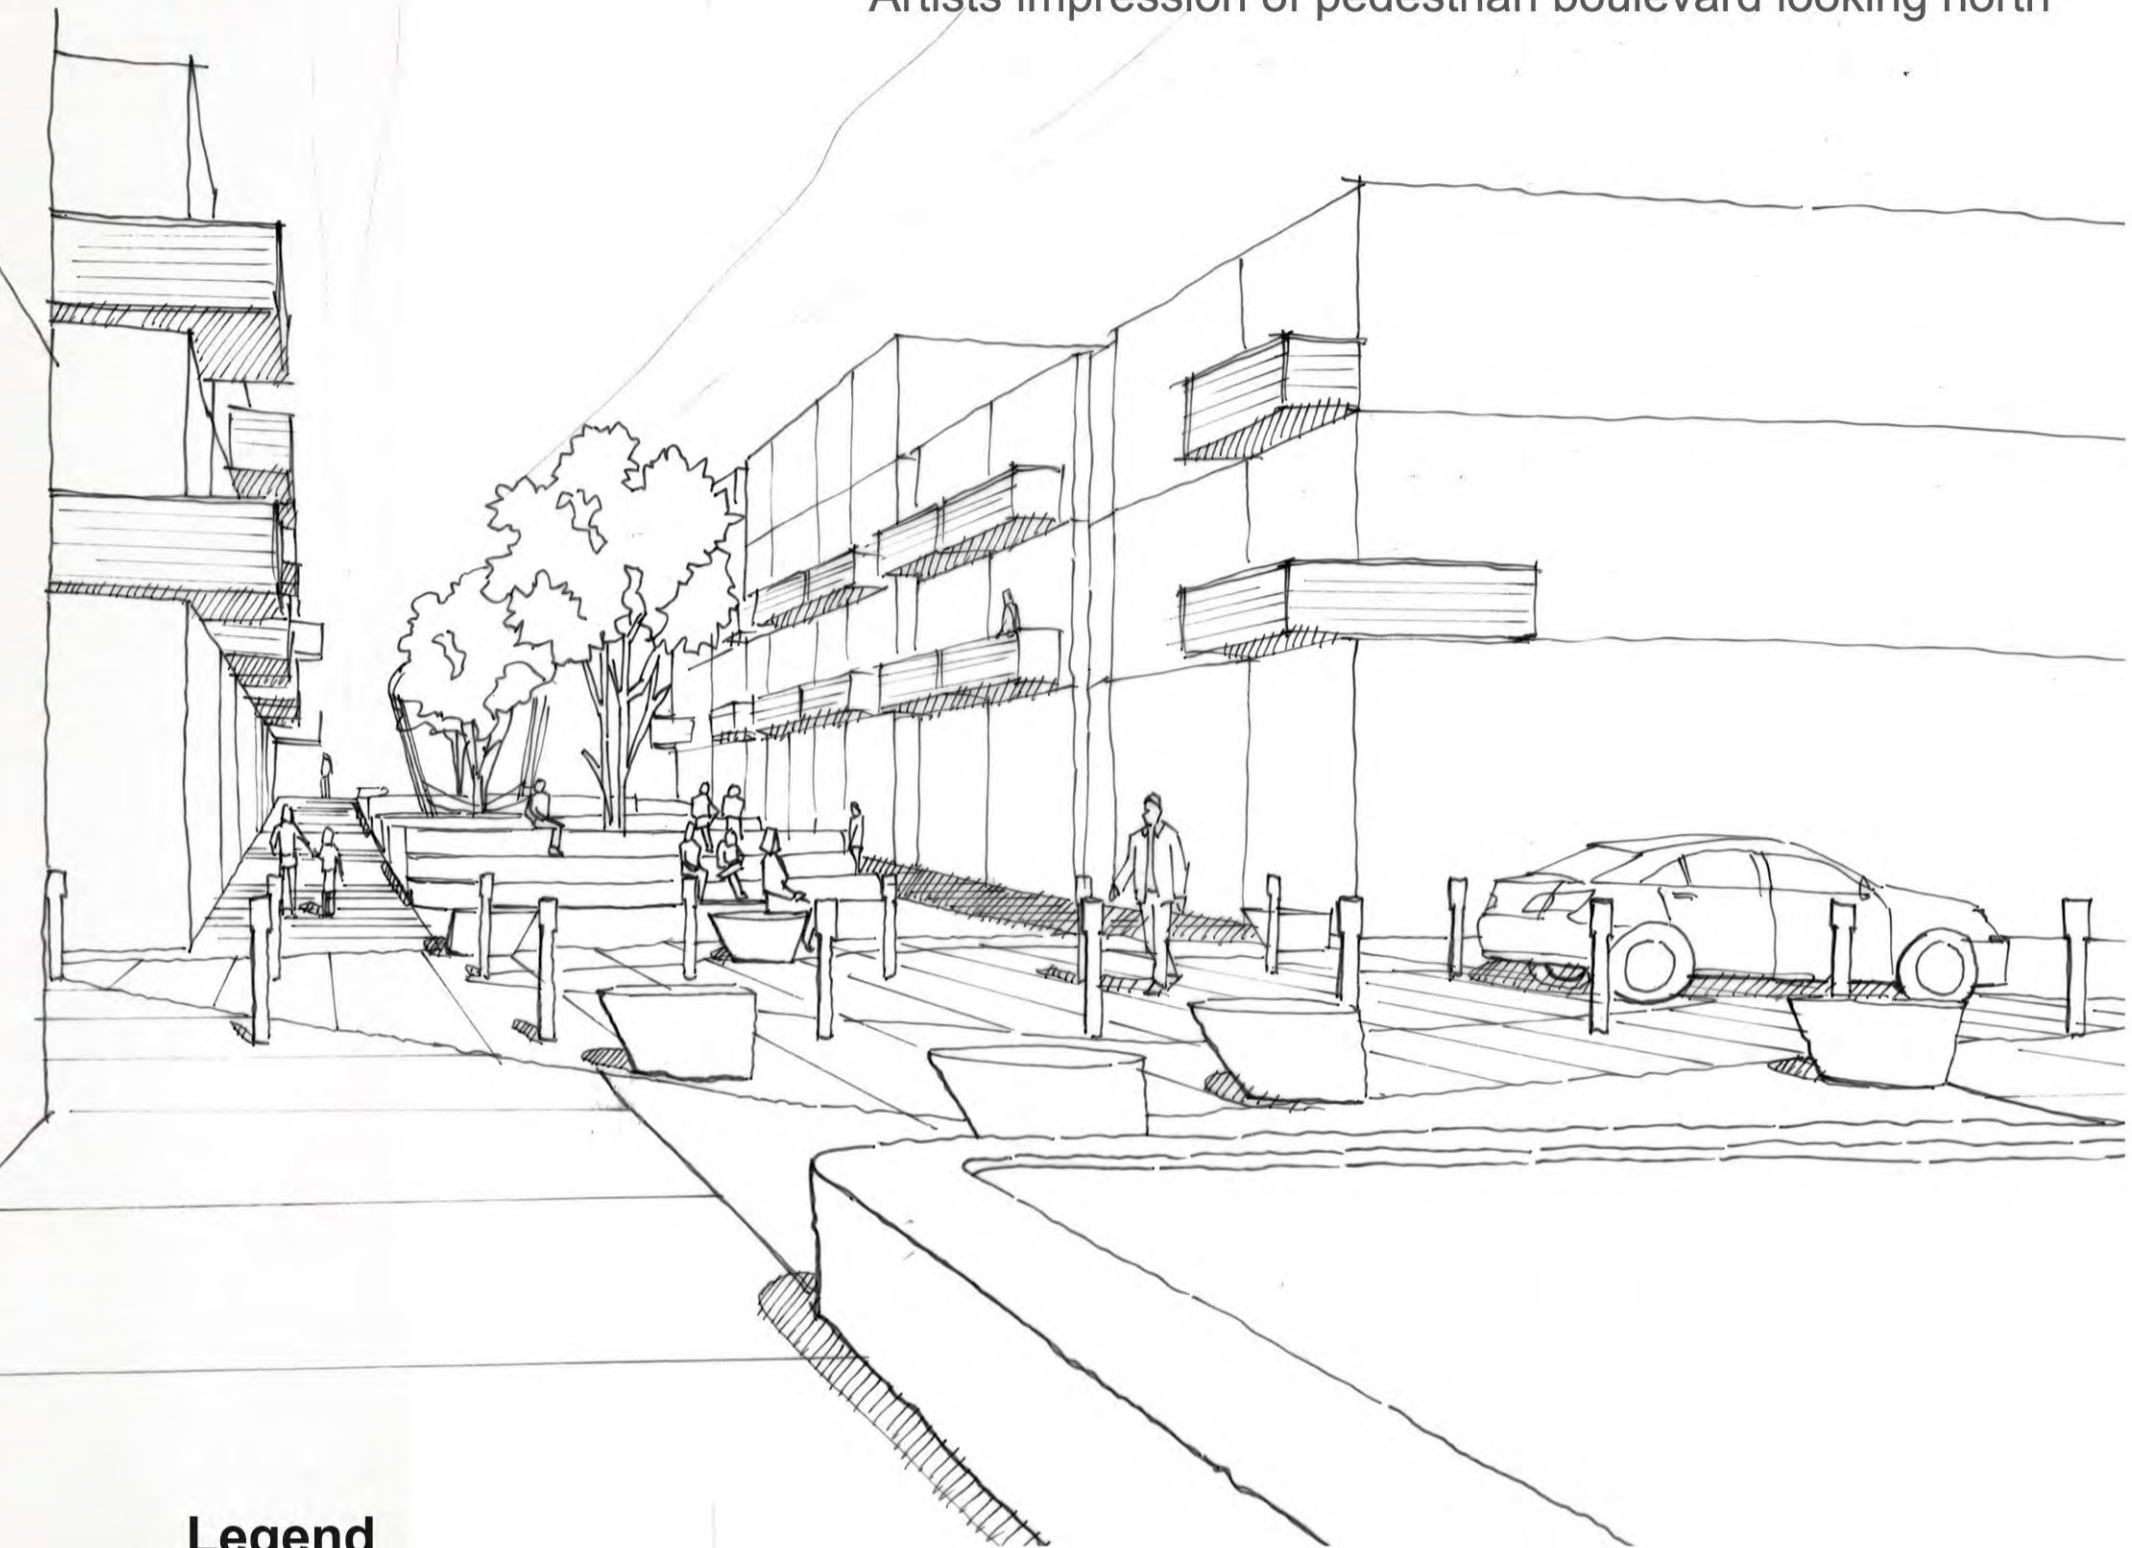
Decorative Gravel
- 1.** Central pedestrian boulevard
- 2.** Central 'car crossing', gives priority to pedestrians

- 3.** Raised and terraced grassed platforms, create a range of spaces along the boulevard for gathering, sitting and playing
- 4.** Feature paving
- 5.** Decorative crushed gravel surfacing enhances the residential character and provides spaces for informal bocce/petanque games

- 6.** Decorative gravel below balcony's
- 7.** Shrub planting creates a green 'setting' for the new buildings
- 8.** Fixed hammocks provide an attractive feature to lure residents out into the shared space

- 9.** Bike Rack
- 10.** 'Sculptural' Seating provides an element of interest, creating a more vibrant public realm
- 11.** Services exit with retaining walls

- 12.** Bollards
- 13.** Cafe/bar alfresco

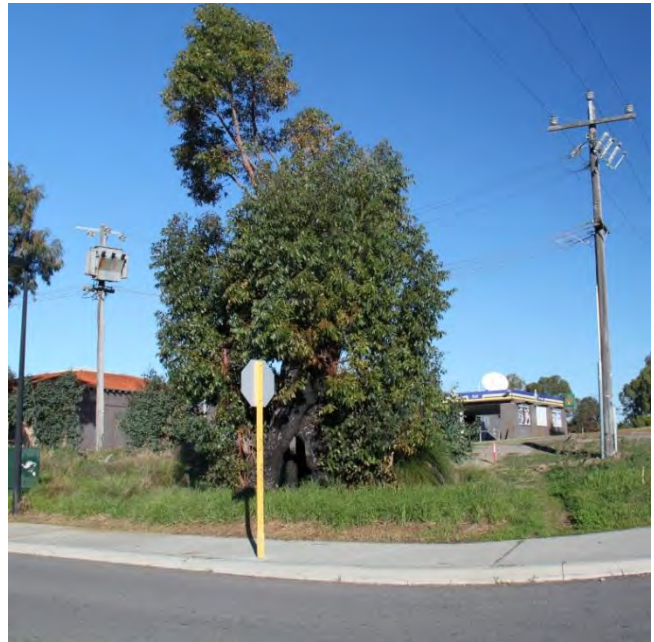
AREA 1: Ceremonial Tree (NE corner)

Tree Health: Poor

Tree Structure: Severely compromised

- Recognised as a 'Ceremonial Tree'
- The specimen has been radically reduced by lopping to provide clearance to adjacent power lines (HV & LV on both its Western and Northern sides).
- The regrowth has superficial attachment that will require on-going foliage load management to ensure tree safety.
- The tree's root zone are has been compromised as a result of soil level changes and excavations in proximity to the tree over many decades.
- Retention of the tree as a worthwhile living specimen will require the establishment of a Tree Preservation Zone (TPZ), and the management of activities within the TPZ throughout the site development phases (**Refer Attachment 1. – Tree Preservation of the 'Ceremonial Tree'**).

Image: Ceremonial Tree

- Tree to be retained.
- Tree Preservation as per Attachment 1.
- Arboriculturist to be appointed to monitor activities.

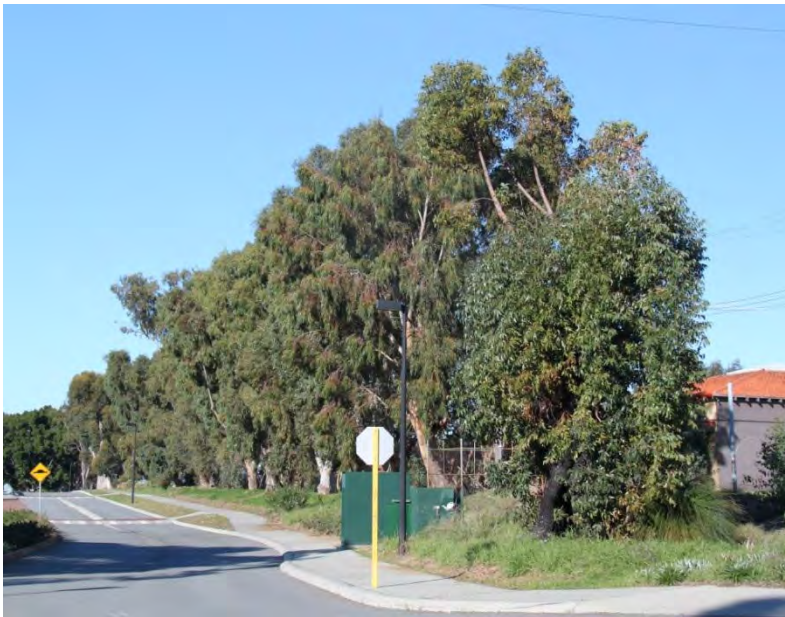
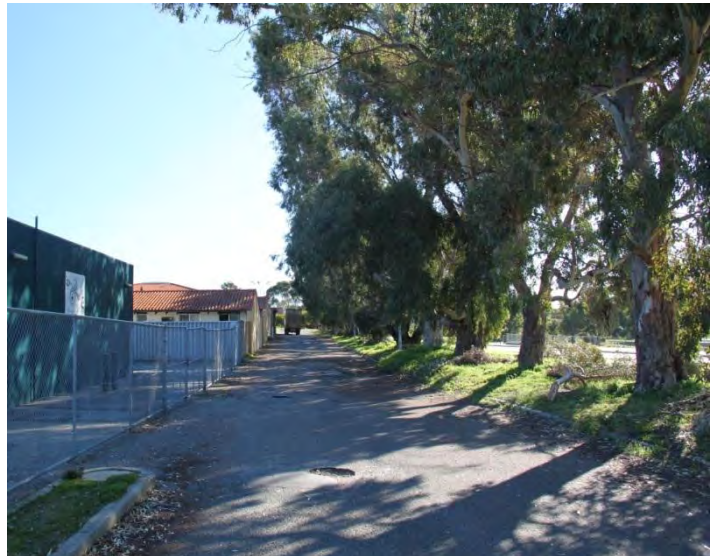
AREA 2: Avenue of 17 x River Gums (Eastern Boundary)

Image: Avenue of River Gums looking South

The avenue of trees have all been severely pruned over the years with the canopies arising from lopped unions ranging from 4m to 10m above ground level.

The trunks of all but 2 of the trees are located on the proposed building alignment and will not survive the development.

Image: Avenue of River Gums looking North

- Removal of all trees.
- Replanting of suitable specimens where appropriate.

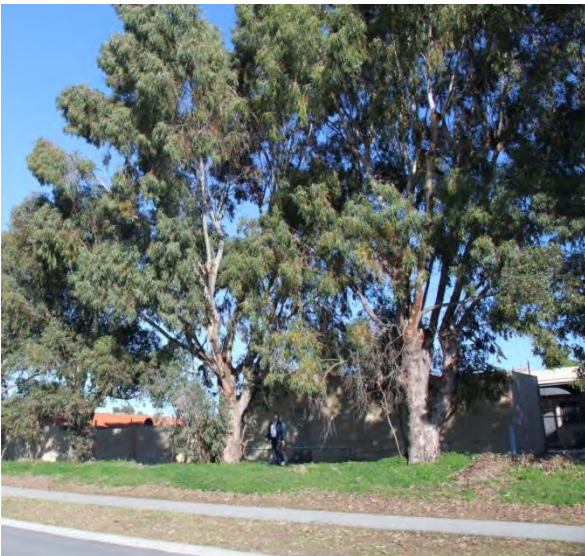
The ninth and tenth specimens from the Waverley Rd end, are located either side of a proposed driveway. The proximity of the trees to excavations that will be required to match up with road levels will likely destabilise the trees as well as challenge their capacity to cope with the inevitable root loss. These specimens have grown reliant on the neighbouring trees for wind protection; their retention without the protection afforded by the neighbouring trees would present inherent structural issues that would require ongoing management. Replacing these trees with new plantings would result in a better outcome.

Image: Two River Gums specimens located either side of proposed driveway

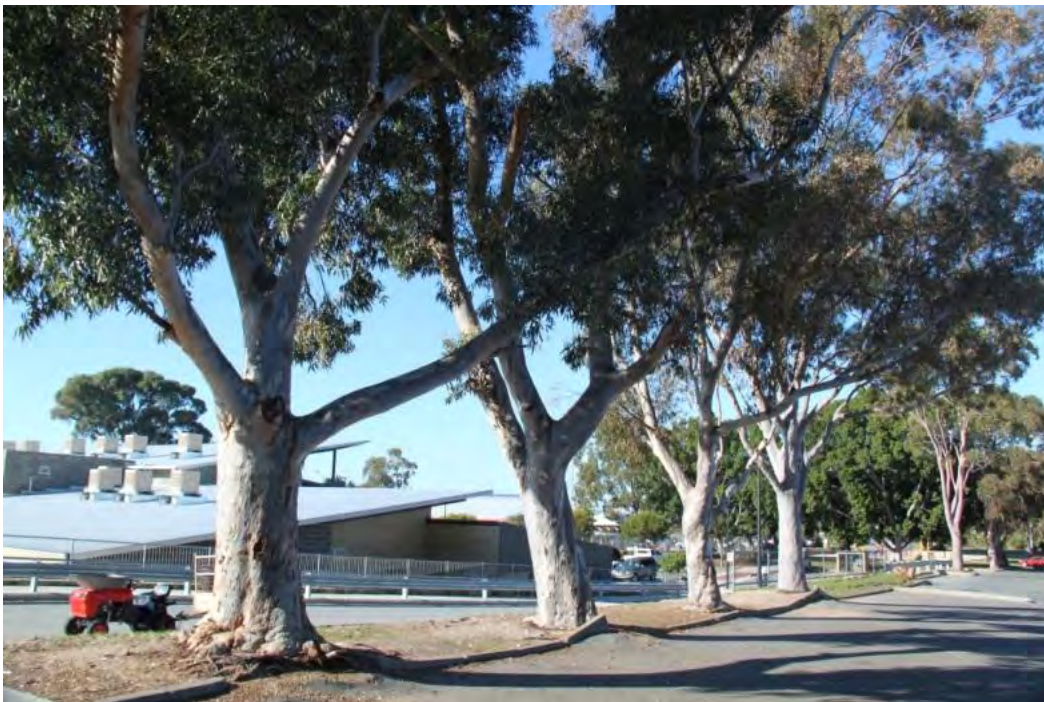
AREA 3: Sugar Gums at the Southern end of the Avenue of 17 x River Gums

The re-working of the service road that passes by these Sugar gums will require further arboricultural input as part of the road design drawings so that the undulations adjacent the trees are addressed without compromising the trees and that the potential for future road disturbance is ameliorated.

Image: Avenue of Sugar Gums

- Trees to be retained.
- Further Arboricultural input into the service road design drawings so that the undulations adjacent the trees are addressed without compromising the trees and the potential for future road disturbance is ameliorated.

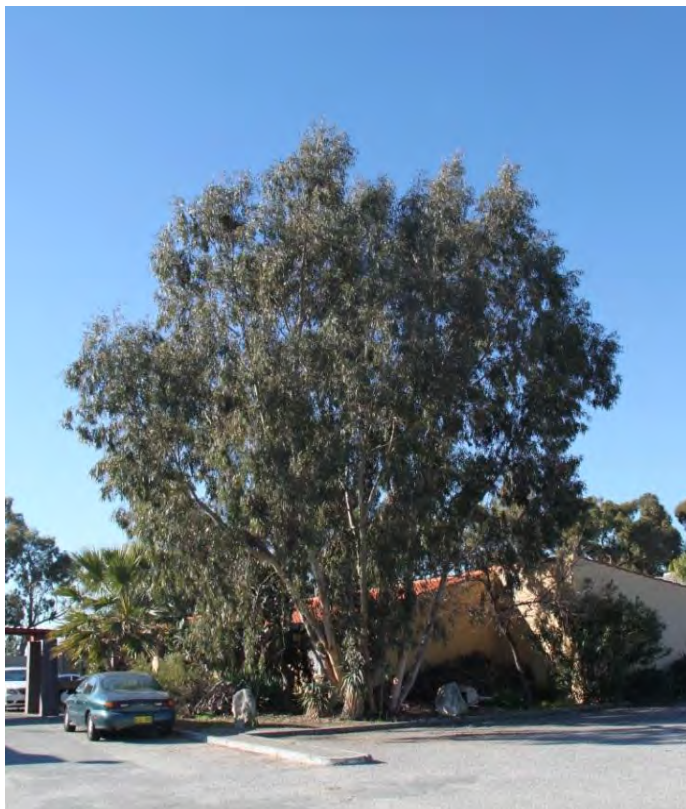
AREA 4: Central Gum Tree

Being coppice regrowth, the tree presents a safety risk that will likely be exacerbated by unavoidable root loss caused by the proposal to contain this specimen within a new planting bed in association with the footprint of the new building. Replanting with a new specimen would achieve a better outcome for the development.

Image: Central Gum Tree

- Removal of the tree.

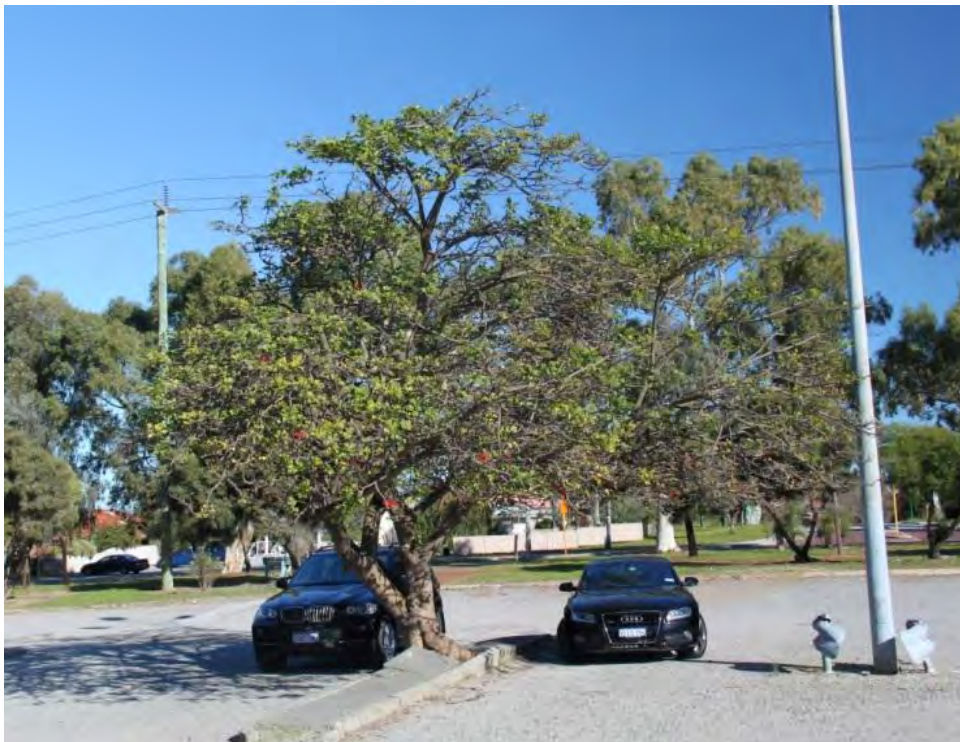
AREA 5: Flame Tree 1

There is potential for this tree to be kept within the proposed new driveway; subject to finished levels and road construction criteria. However, it is not a good specimen of the species and is in poor condition.

Image: Flame Tree 1

- Poor specimen however, there is potential to retain the tree in-situ.
- Retention subject to finished levels and the practicalities associated with road and pavement construction.

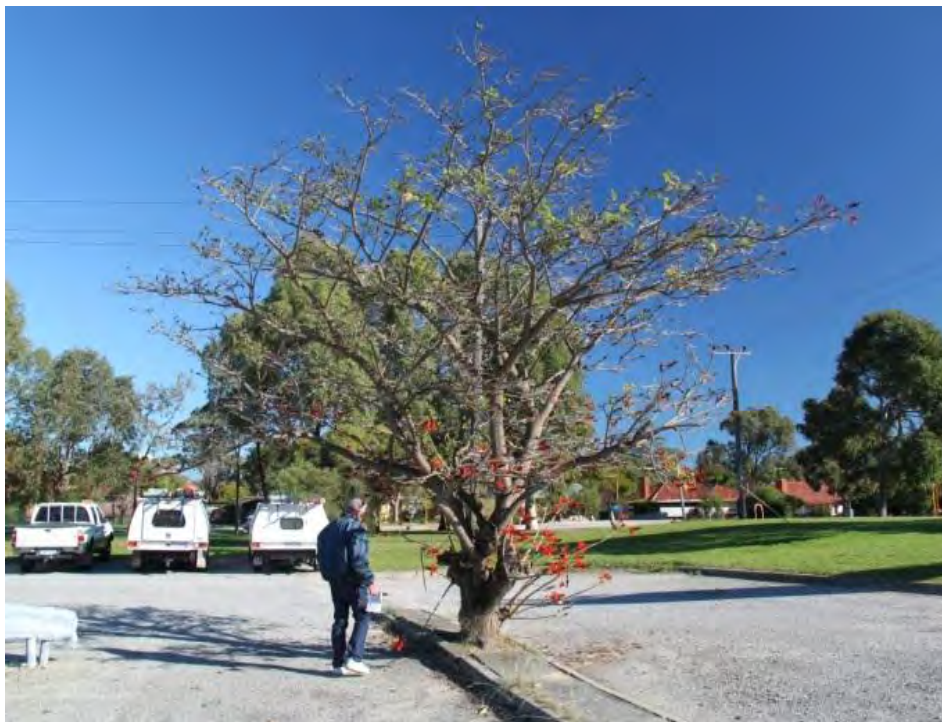
AREA 6: Flame Tree 2

A very poor specimen of the species that is structurally compromised by past topping and not worth transplanting. Its survival in this environmental extreme is testament to the species resilience.

Image: Flame Tree 2

- Removal of the tree.

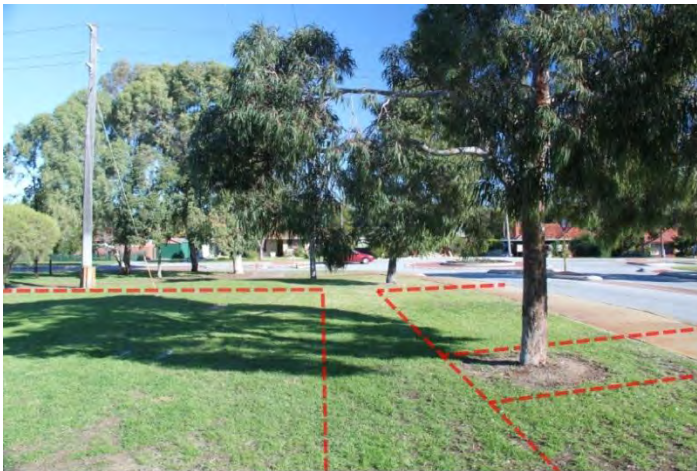
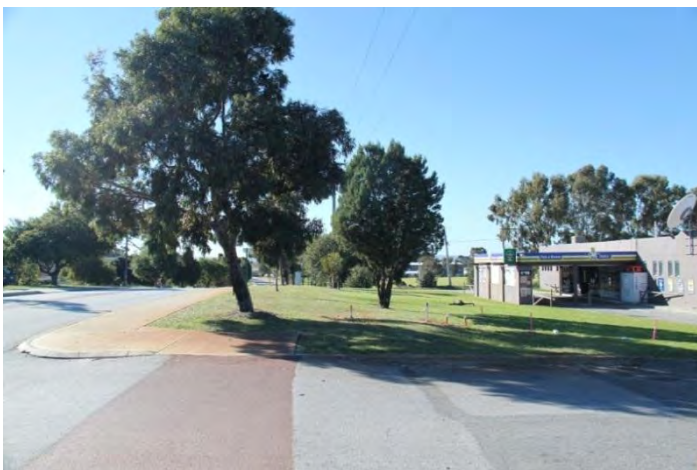
AREA 7: Waverley Road Side

The proposal to incorporate the 4 x *Angophora costata*'s into a car bay sized nib and install a footpath on the other side of the trees (as indicated in red) will likely see the trees die within a few years or at best, cause them to underperform and become a blight on the streetscape.

- Similar consideration will need to be afforded the Rottnest Island Pine (*Calitris preissii*).
- The *Angophora* that is second from the East end is in very poor condition and is not worthwhile retaining. Better to replace it with a new specimen.

Image: Waverley Road verge looking West.
Note: Footpath and nib outline indicative only.

Image: Waverley Road verge looking East with Rottnest Island Pine (*Calitris preissii* in foreground)

Given the maturity of these 4 *Angophora*'s it will be necessary to increase the nib size to at least 2 car bays (preferably 3) and divert the footpath to provide a minimum 1.5m radius between the edge of foot path and the tree trunk. Further, there will need to be a root pruning protocol and a watering regime to coincide with the works being done. Additional arboricultural input required for this to be incorporated into the construction details once the final levels have been determined for the road/parking design.

- 4 of the five Angophoras are worthwhile retaining however additional space around the trees is required for this to be successfully achieved (increase the nib size to at least 2

car bays (preferably 3) and divert the footpath to provide a minimum 1.5m radius between the edge of foot path and the tree trunk).

- 1 x Calitris will require similar consideration
- Further arboricultural input into the final alignments of parking bays and footpaths will be required.
- Tree preservation measures to include timely Root pruning, Canopy pruning, Watering regimes and Tree protection measures.
- Tree preservation specifications to be incorporated in the construction documentation.

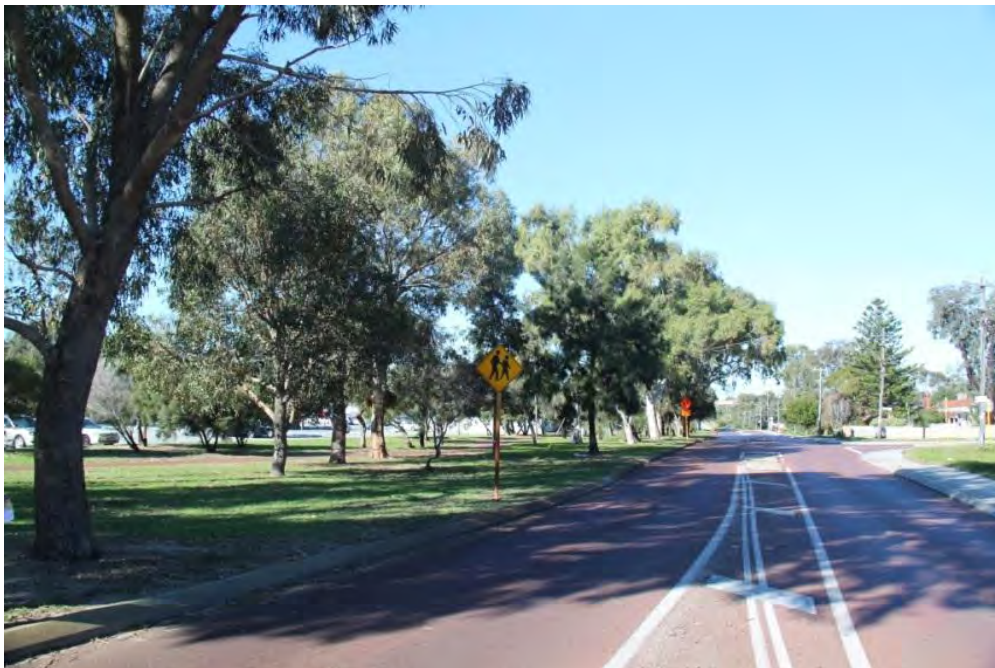
AREA 8: Coolbellup Drive – Proposed Parking

- All of the trees are in reasonable health and appear to be structurally typical for the species.
- Re-routing of the main path and the introduction of new footpaths will also require root pruning operations to precede any boxing out works for the construction of the paths and a tree watering regime implemented as directed by the Arboriculturist.

Image: Coolbellup Drive looking South.

Parking bays A – E will require root pruning to precede any boxing out for the construction of the bays and a tree watering regime implemented as directed by the Arboriculturist. Suggest that such detail is incorporated into the specification documentation.

- Construction detail to include the engagement of the Arboriculturist to perform &/or oversee tree preservation activities including timely root pruning, canopy pruning, watering regimes and tree protection measures.
- Tree preservation specifications to be incorporated in the construction documentation.

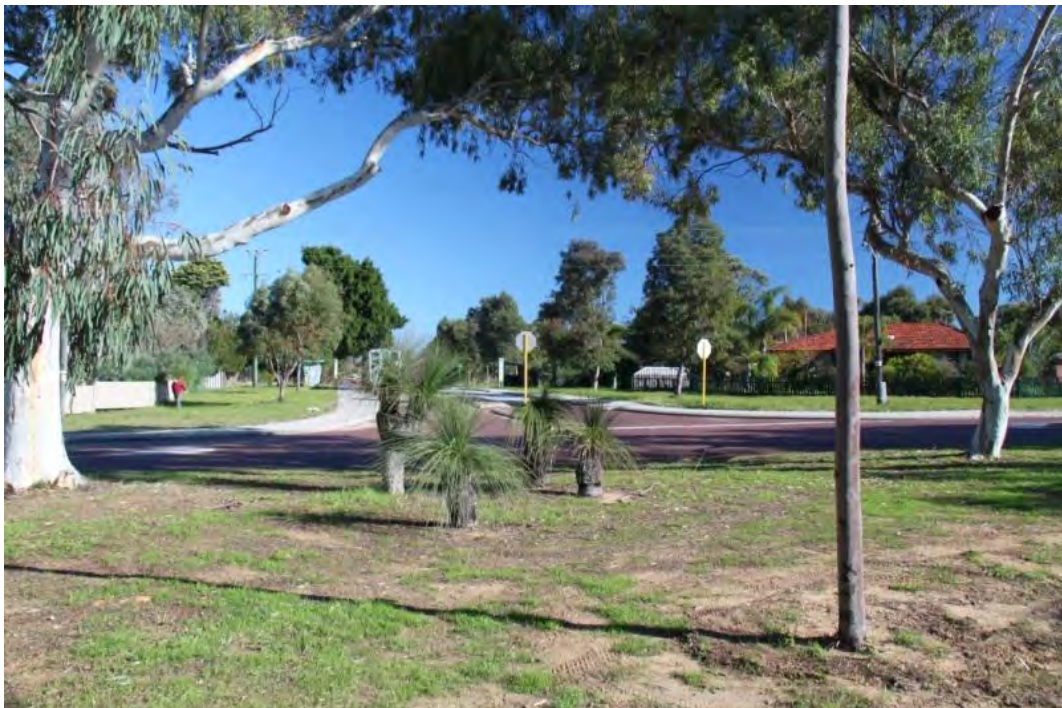
AREA 9: Coolbellup Drive – New Entry Road

Image: Looking West from Proposed Entry off Coolbellup Drive.

Retaining the two Eucalypts either side of the new entry road will require tree specific tree preservation measures as directed by the Arboriculturist. This will include:

- Canopy pruning,
- Root pruning,
- Watering regime,
- Tree protection measures.

- Construction detail to include the engagement of the Arboriculturist to perform &/or oversee tree preservation activities including timely root pruning, canopy pruning, watering regimes and tree protection measures.
- Tree preservation specifications to be incorporated in the construction documentation.

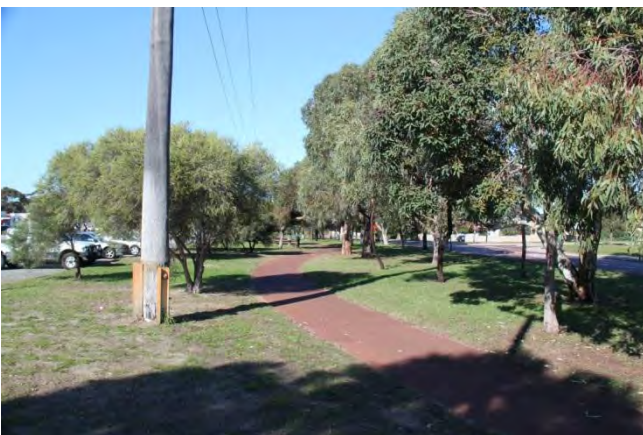
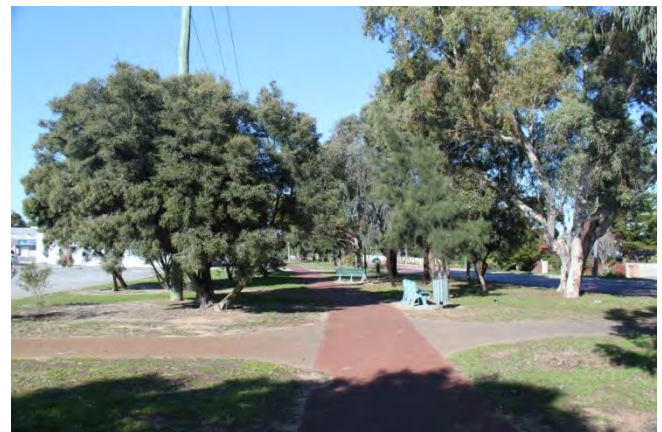
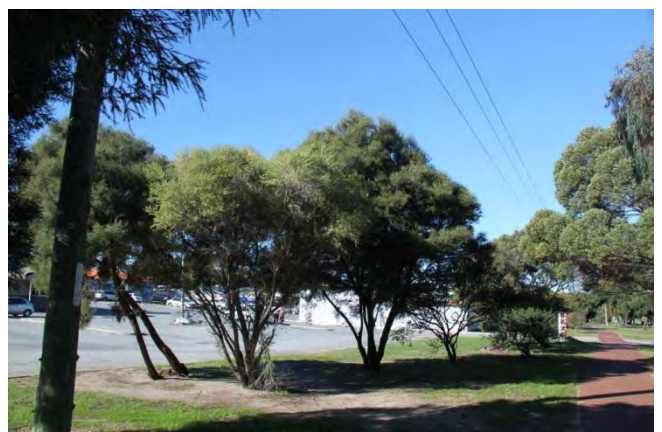
AREA 10: Coolbellup Drive – Parking on East Side of Verge

This strip of low growing trees are largely made up of Rottnest Island Tea Tree (*Melaleuca lanceolata*), some Callistomens (*Callistomen viminalis*) and a few Kunzeas (*Kunzea* spp.), that are in reasonable condition and structurally typical for the species.

Images: Looking South along Coolbellup Drive Verge

A re-configuration of the parking bays would eliminate the loss of some of the more worthwhile specimens.

The retention of worthwhile specimens will require tree specific tree preservation measures being applied as directed by the Arboriculturist. This will include:

- Canopy pruning,
- Root pruning,
- Watering regime,
- Tree protection measures.

- Construction detail to include the engagement of the Arboriculturist to perform &/or oversee tree preservation activities including timely Root pruning, Canopy pruning, Watering regimes and Tree protection measures.
- Tree preservation specifications to be incorporated in the construction documentation.

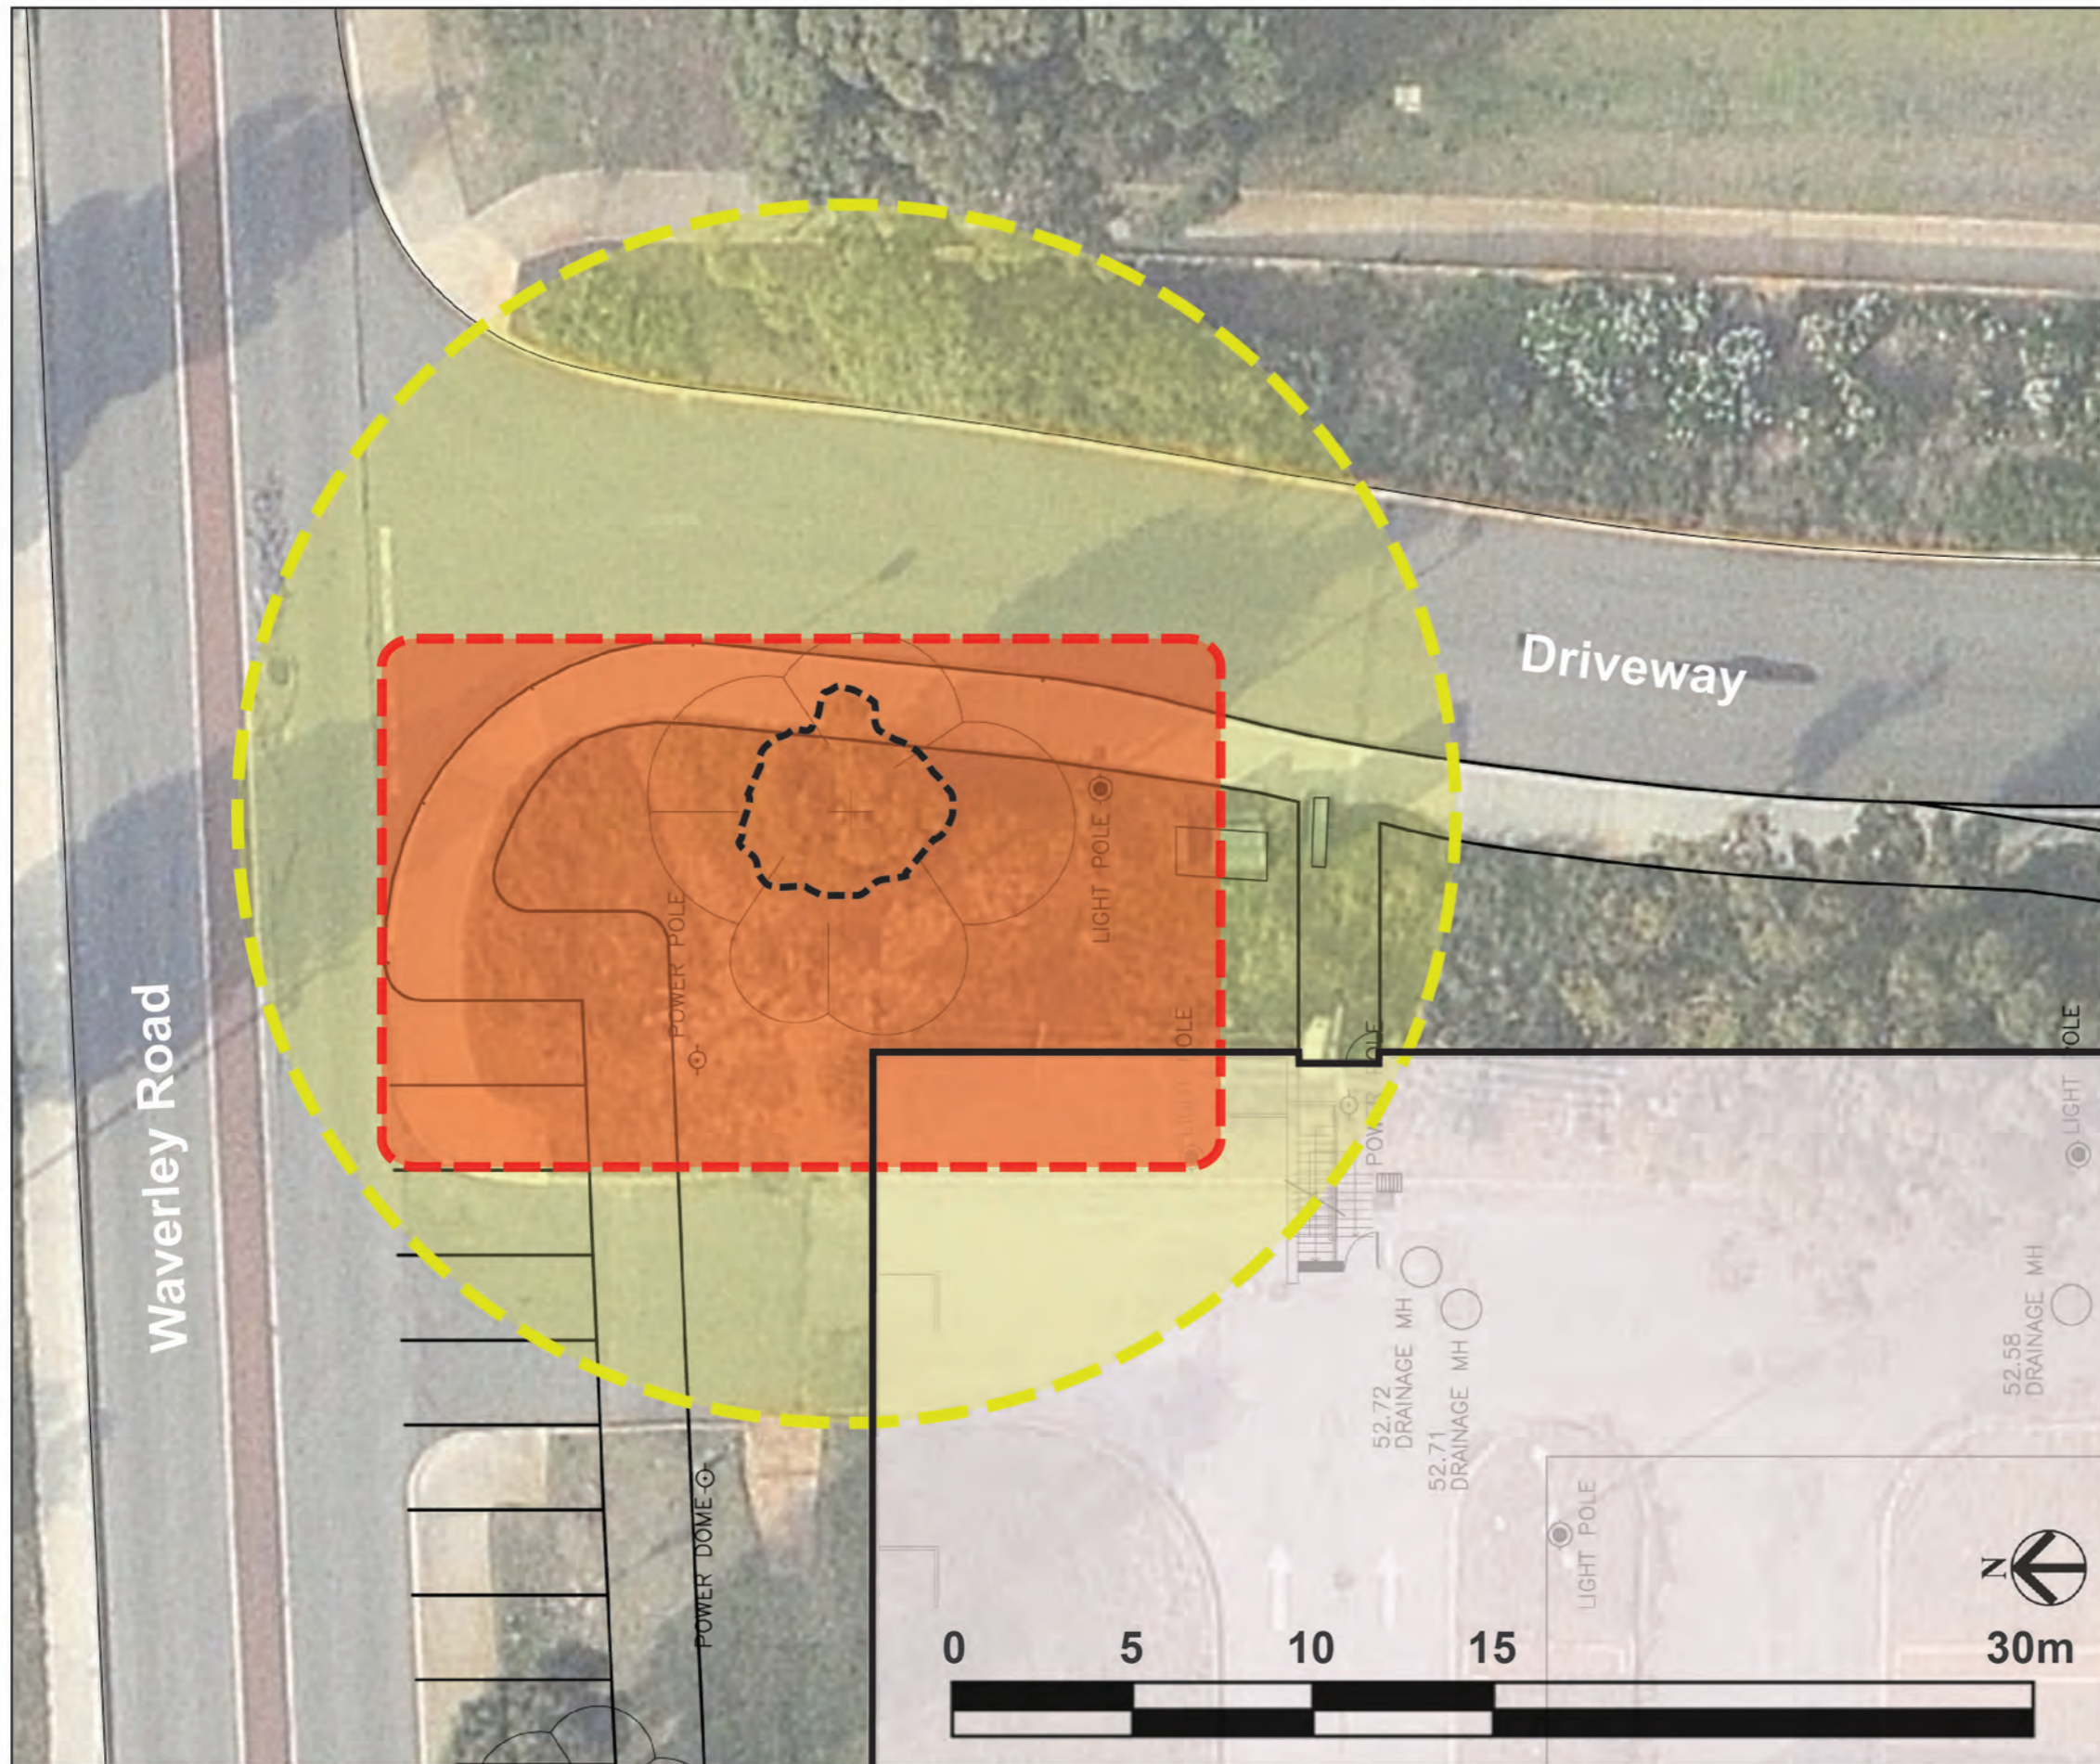
ATTACHMENT 1: Tree Preservation of 'Ceremonial Tree'

Note: Proposed building encroaches into both TPZ's.

Further assessment of proposed works and methodologies will be required so that appropriate measures can be taken to offset their potential impact on the tree.

1. The area shaded red is to be treated as the Tree Preservation Zone (TPZ)

- The area is cordoned off with construction type panel fencing and labelled “TREE PRESERVATION ZONE - DO NOT ENTER WITHOUT AUTHORISATION”.
- No open trench excavation is to occur within this zone without further arboricultural input. (Note: All new below ground services (or upgrades), to be installed via boring at min 800mm depth where possible &/or measures taken to offset the potential impact of works within the Recommended Tree Preservation Zone).

- No soil level changes to occur without approval by the Arboriculturist.
- The area is to be weed controlled and mulched as directed by the Arboriculturist.

- A watering regime will form part of the remediation works that are to be identified by the Arboriculturist.
- Selective canopy pruning under the supervision of the Arboriculturist.

- All new or remediation works to footpaths, kerbs or roads to be approved by the Arboriculturist prior to commencement.
