# DAVILAK RUINS ARCHAEOLOGICAL MANAGEMENT STRATEGY MANNING ESTATE, HAMILTON HILL

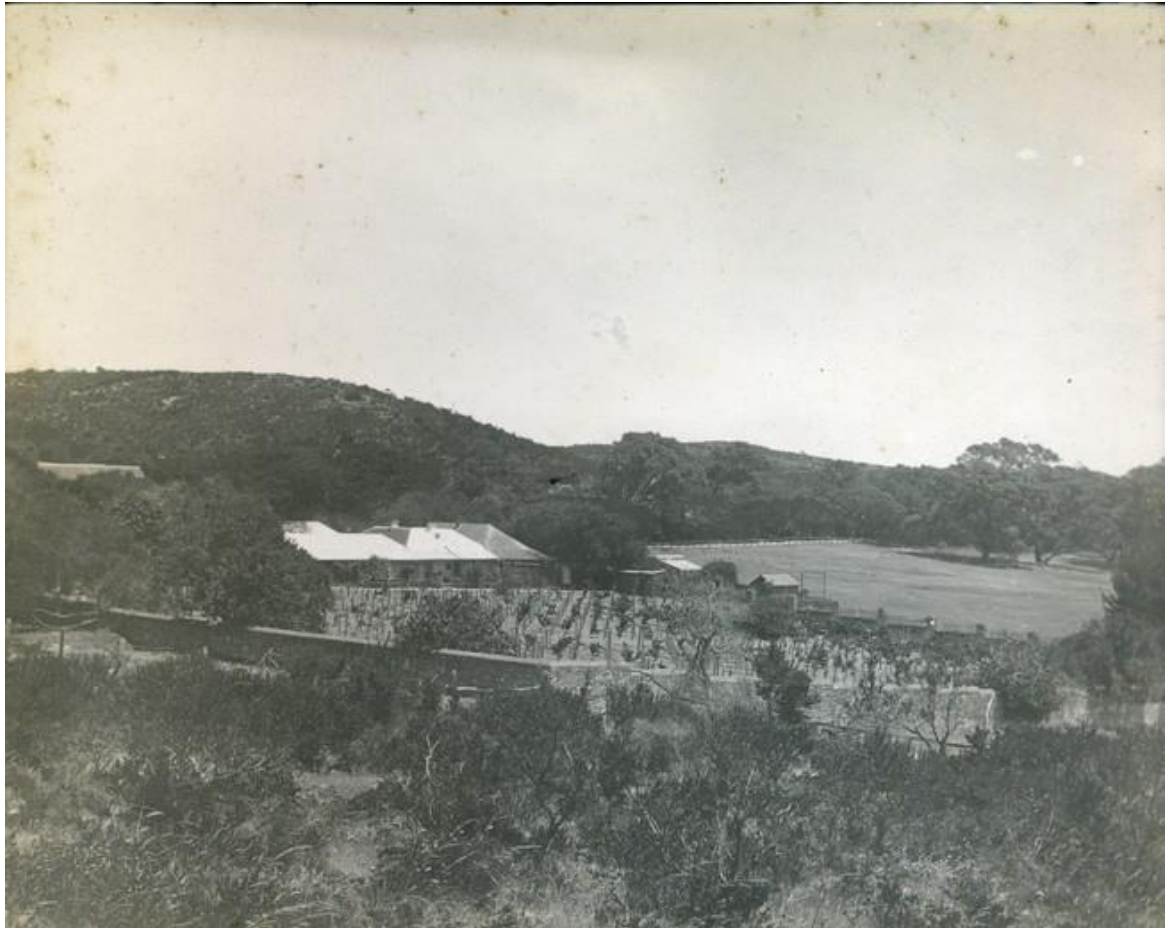
**Plate 1** View of the vineyard and the eastern side of Davilak Homestead c.1900 (Courtesy City of Cockburn Library)

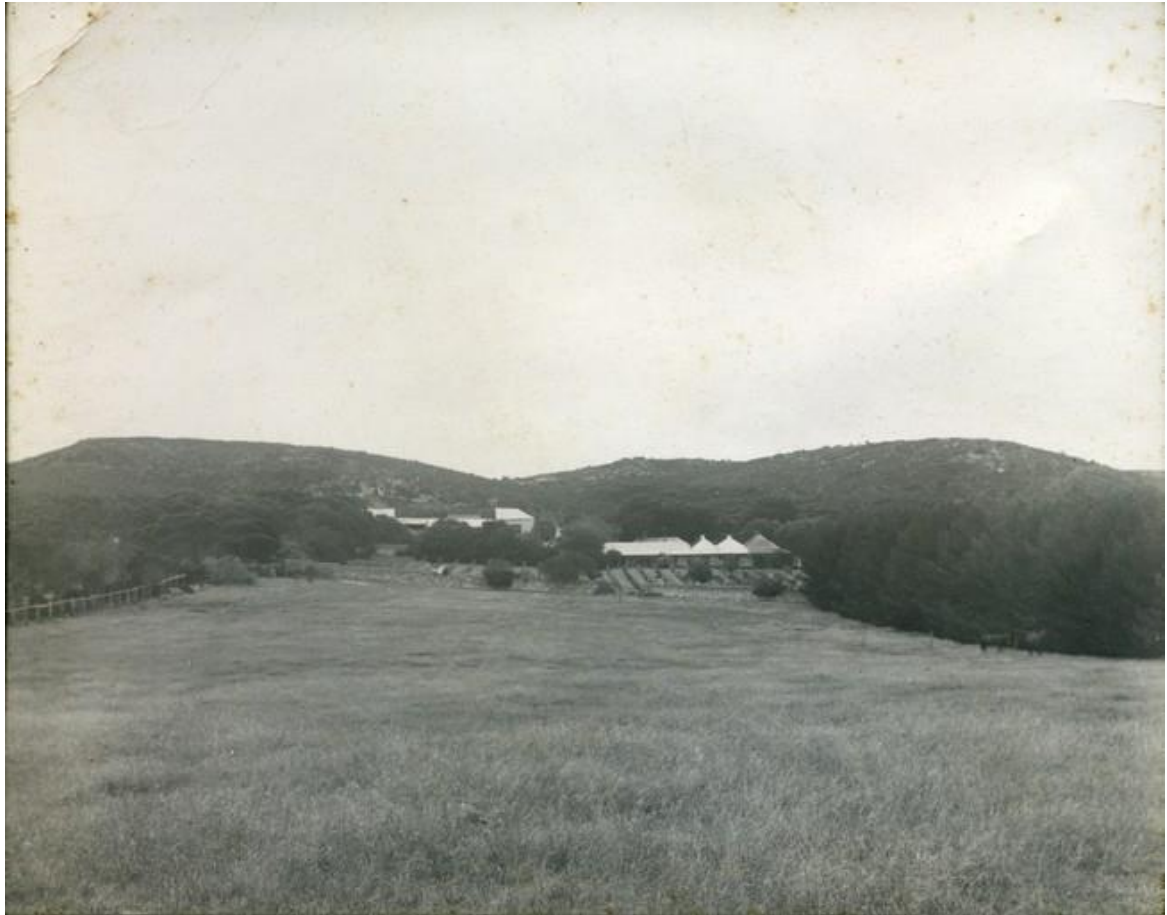
**Plate 2** View looking west across paddocks towards Davilak. The long line of the homestead can be seen on the right and beyond, to the left are the farm buildings. The line of vines can be clearly seen in front of the homestead. (Courtesy City of Cockburn Library).
