DEVELOPMENT AREA 19 (MURIEL COURT)

LOCAL WATER MANAGEMENT STRATEGY

Job No:	<i>09.181</i>
Report No:	<i>11/123</i>
Prepared by:	<i>John Hunt</i>
Status:	<i>Approved</i>
QA Review:	<i>Paul Zahra</i>
Technical Review:	<i>Karen Lane</i>
Content Review:	<i>Karen Lane</i>
Date:	<i>20 September 2011</i>

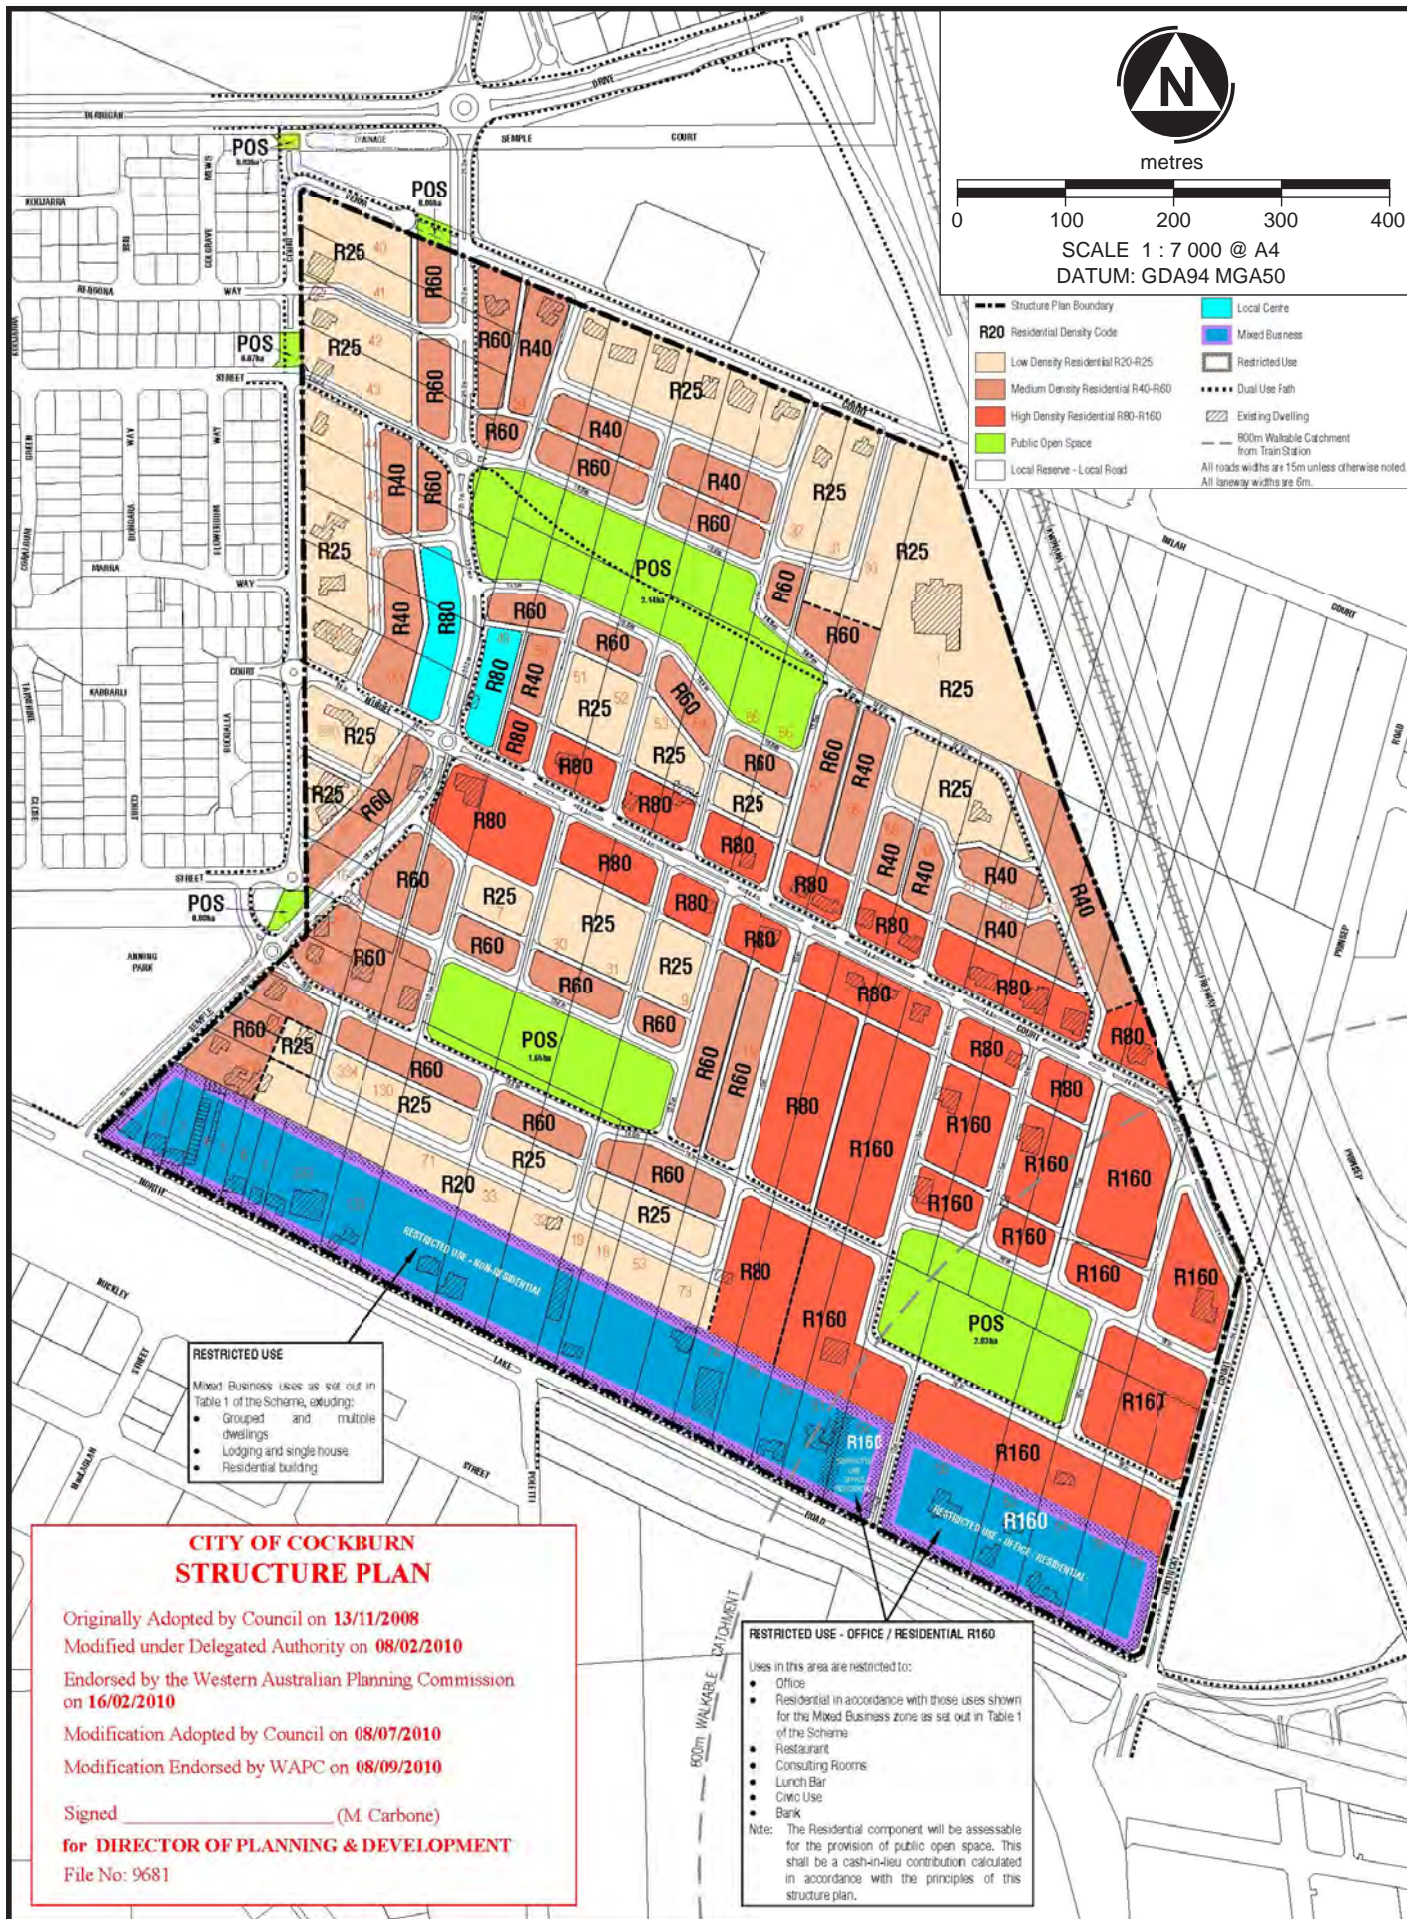
FIGURE 2

City of Cockburn
 AREA 19 MURIEL COURT, COCKBURN CENTRAL
 LOCAL WATER MANAGEMENT STRATEGY
STRUCTURE PLAN

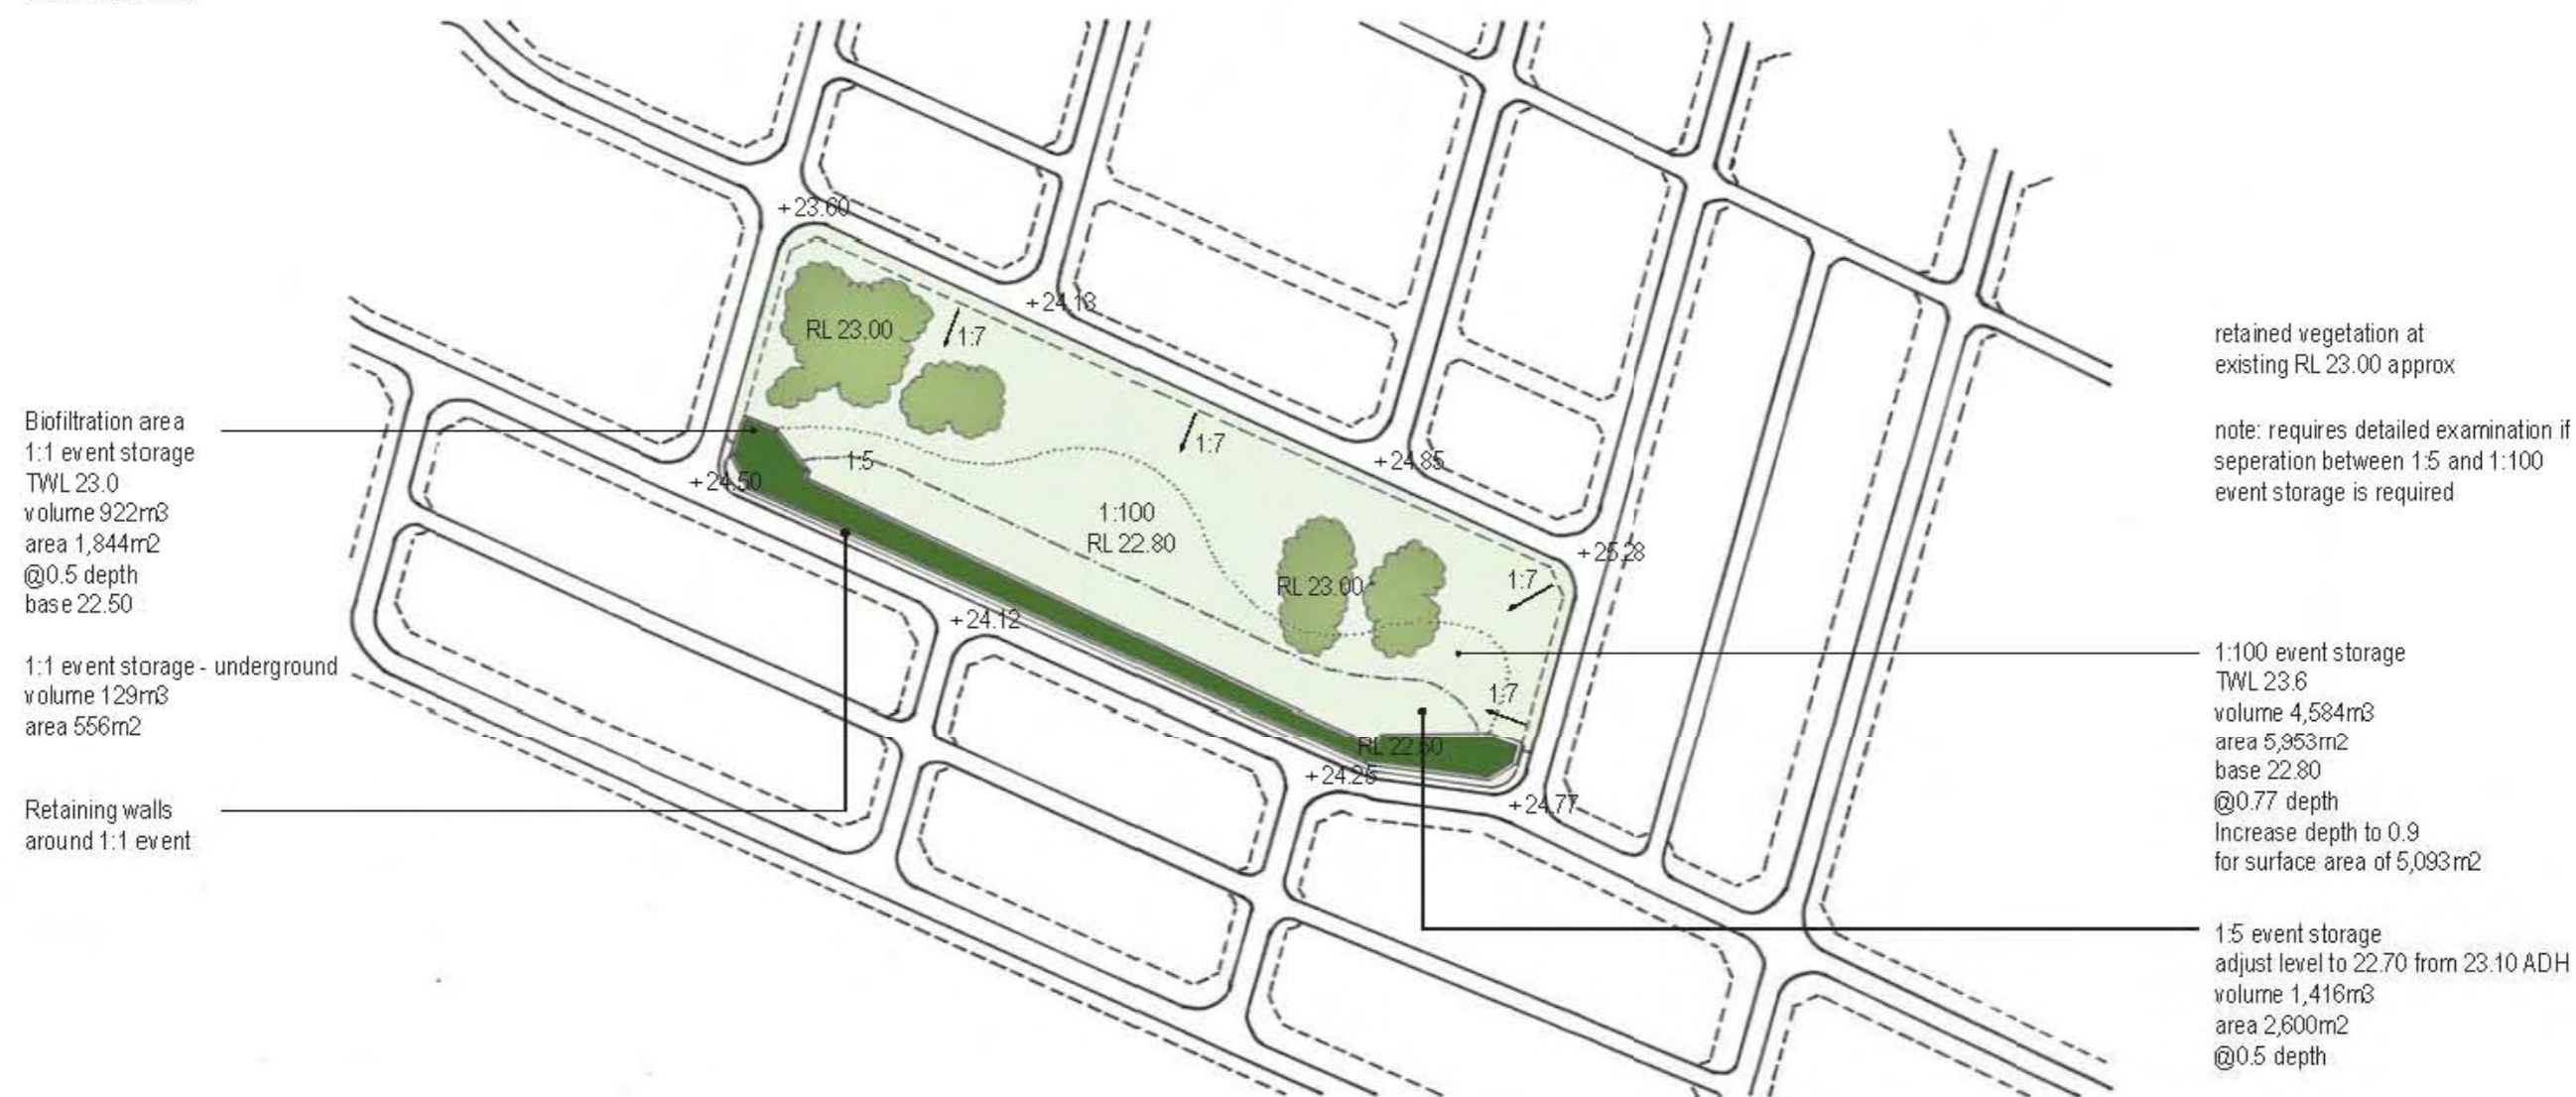
landscape sketch plan

- Notes:
- tree value and quality to be assessed onsite at POS design stage, to confirm if retention is suitable,
 - existing grass trees to be removed & relocated prior to earthworks,
 - no separation between 1:5 and 1:100 storage,
 - 1:5 event overtops 1:1,
 - maximum depth
 - 1:1 -- 500mm
 - 1:5 -- 800mm
 - 1:100 -- 1500mm

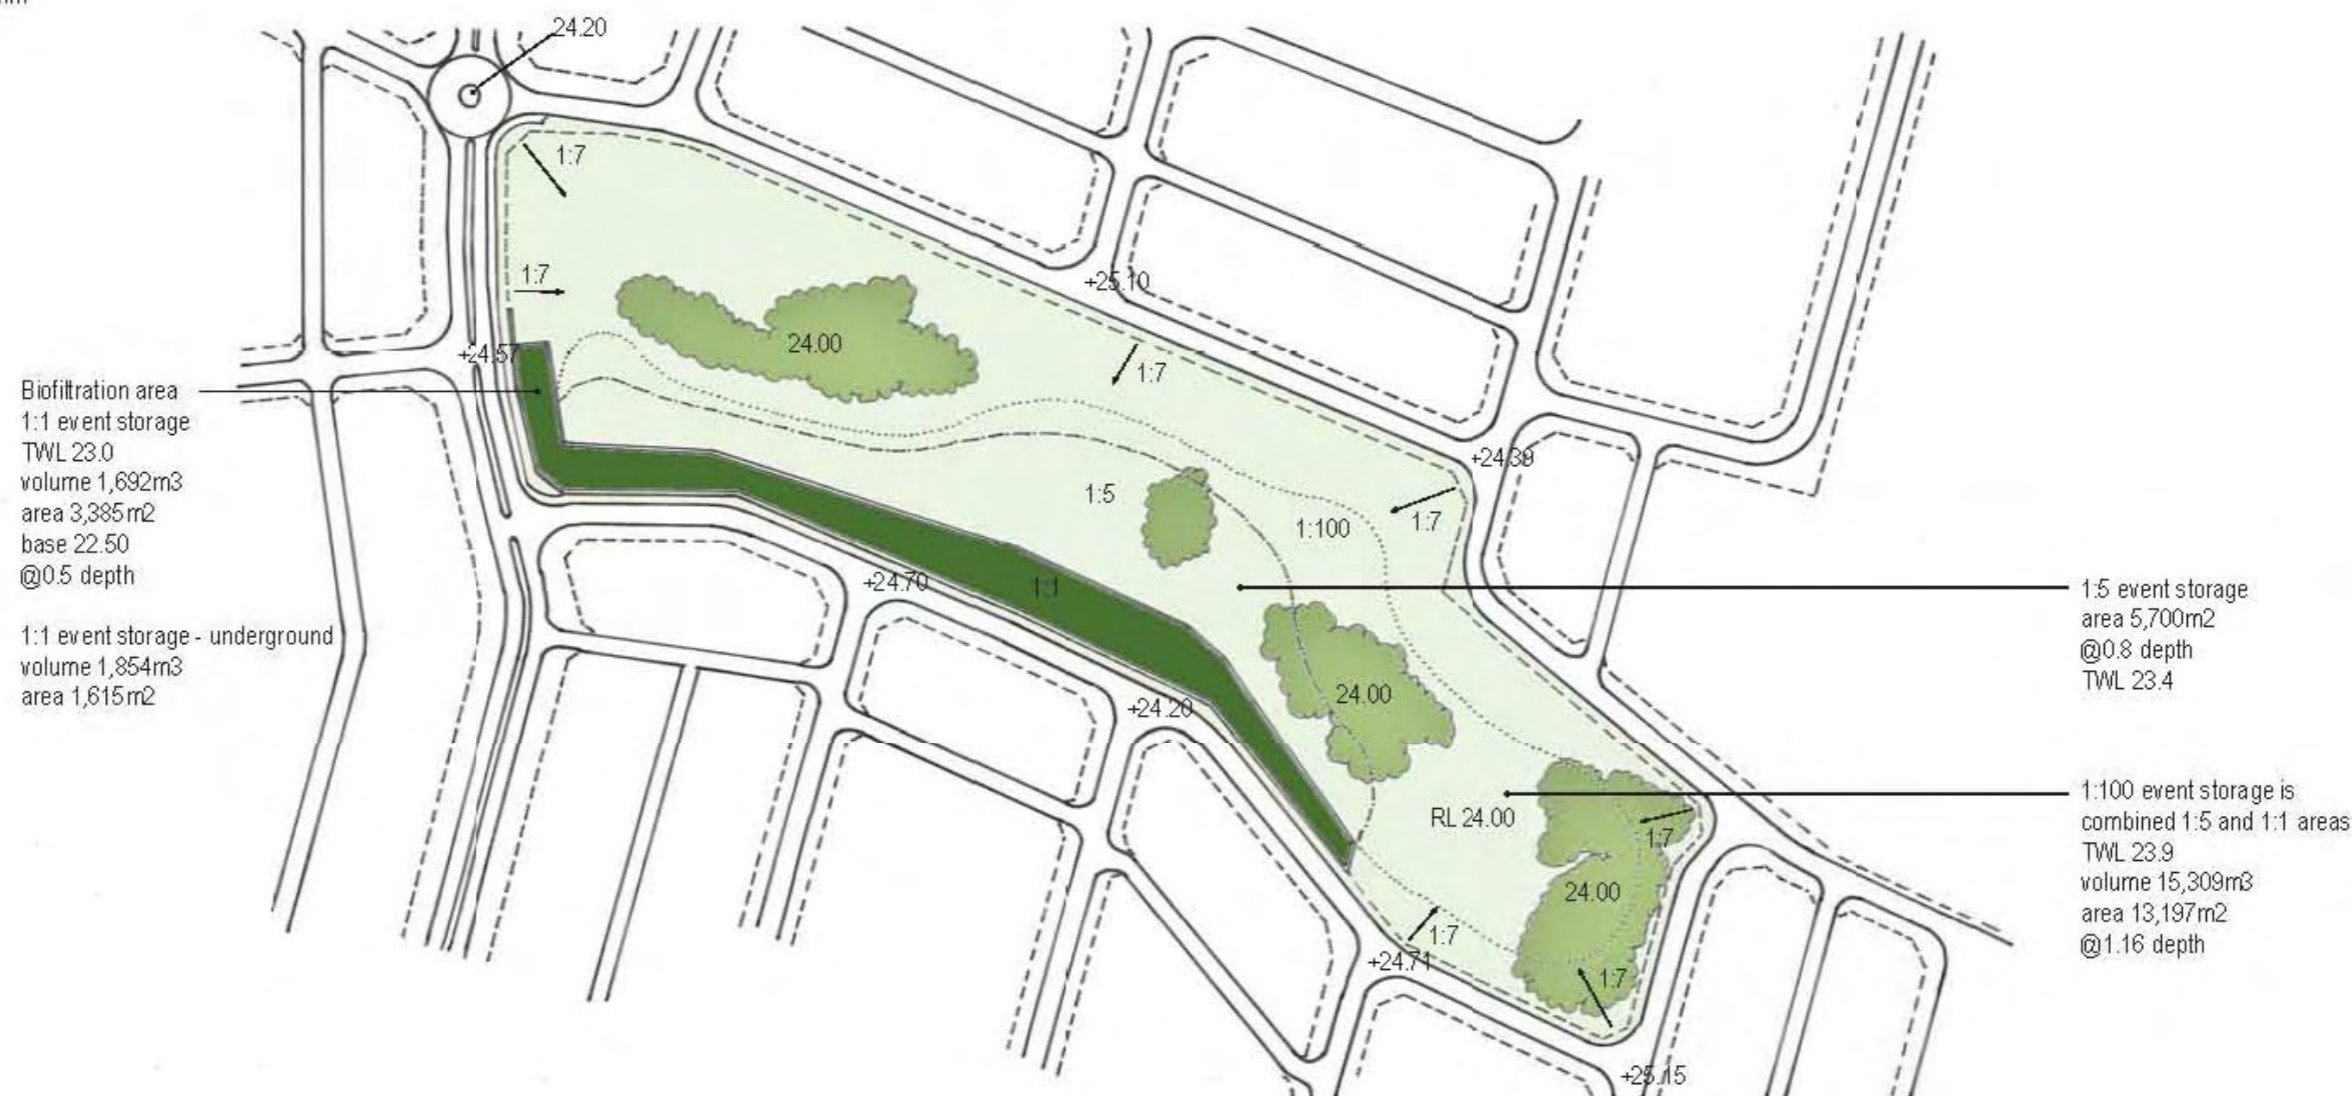
landscape sketch plan

- Notes:
- tree value and quality to be assessed onsite at POS design stage, to confirm if retention is suitable,
 - existing grass trees to be removed & relocated prior to earthworks,
 - no separation between 1:5 and 1:100 storage,
 - 1:5 event overtops 1:1,
 - maximum depth
 - 1:1 -- 500mm
 - 1:5 -- 800mm
 - 1:100 -- 1500mm

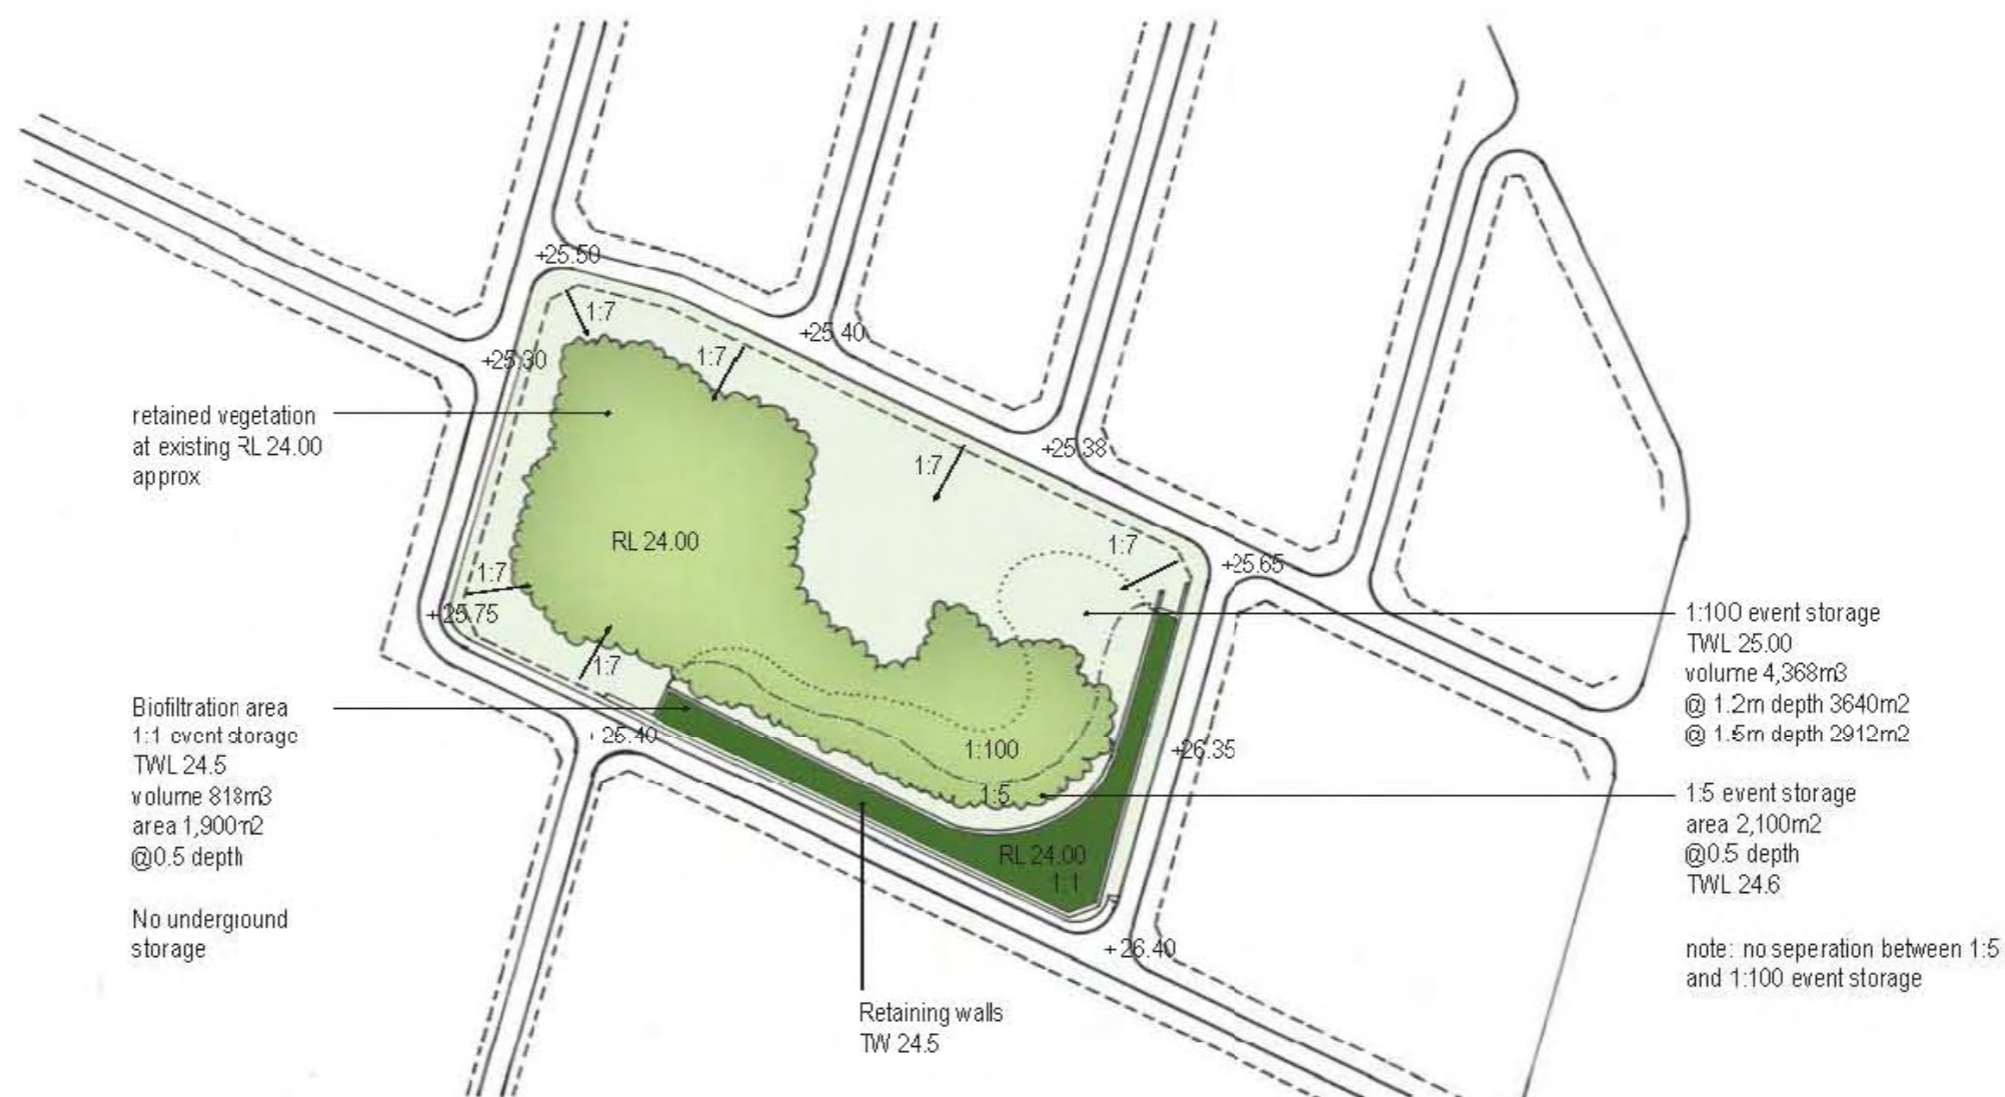
landscape sketch plan

- tree value and quality to be assessed onsite at POS design stage, to confirm if retention is suitable,
- existing grass trees to be removed & relocated prior to earthworks,
- no separation between 1:5 and 1:100 storage,
- 1:5 event overtops 1:1,
- maximum depth 1:1 -- 500mm
1:5 -- 800mm
1:100 -- 1500mm

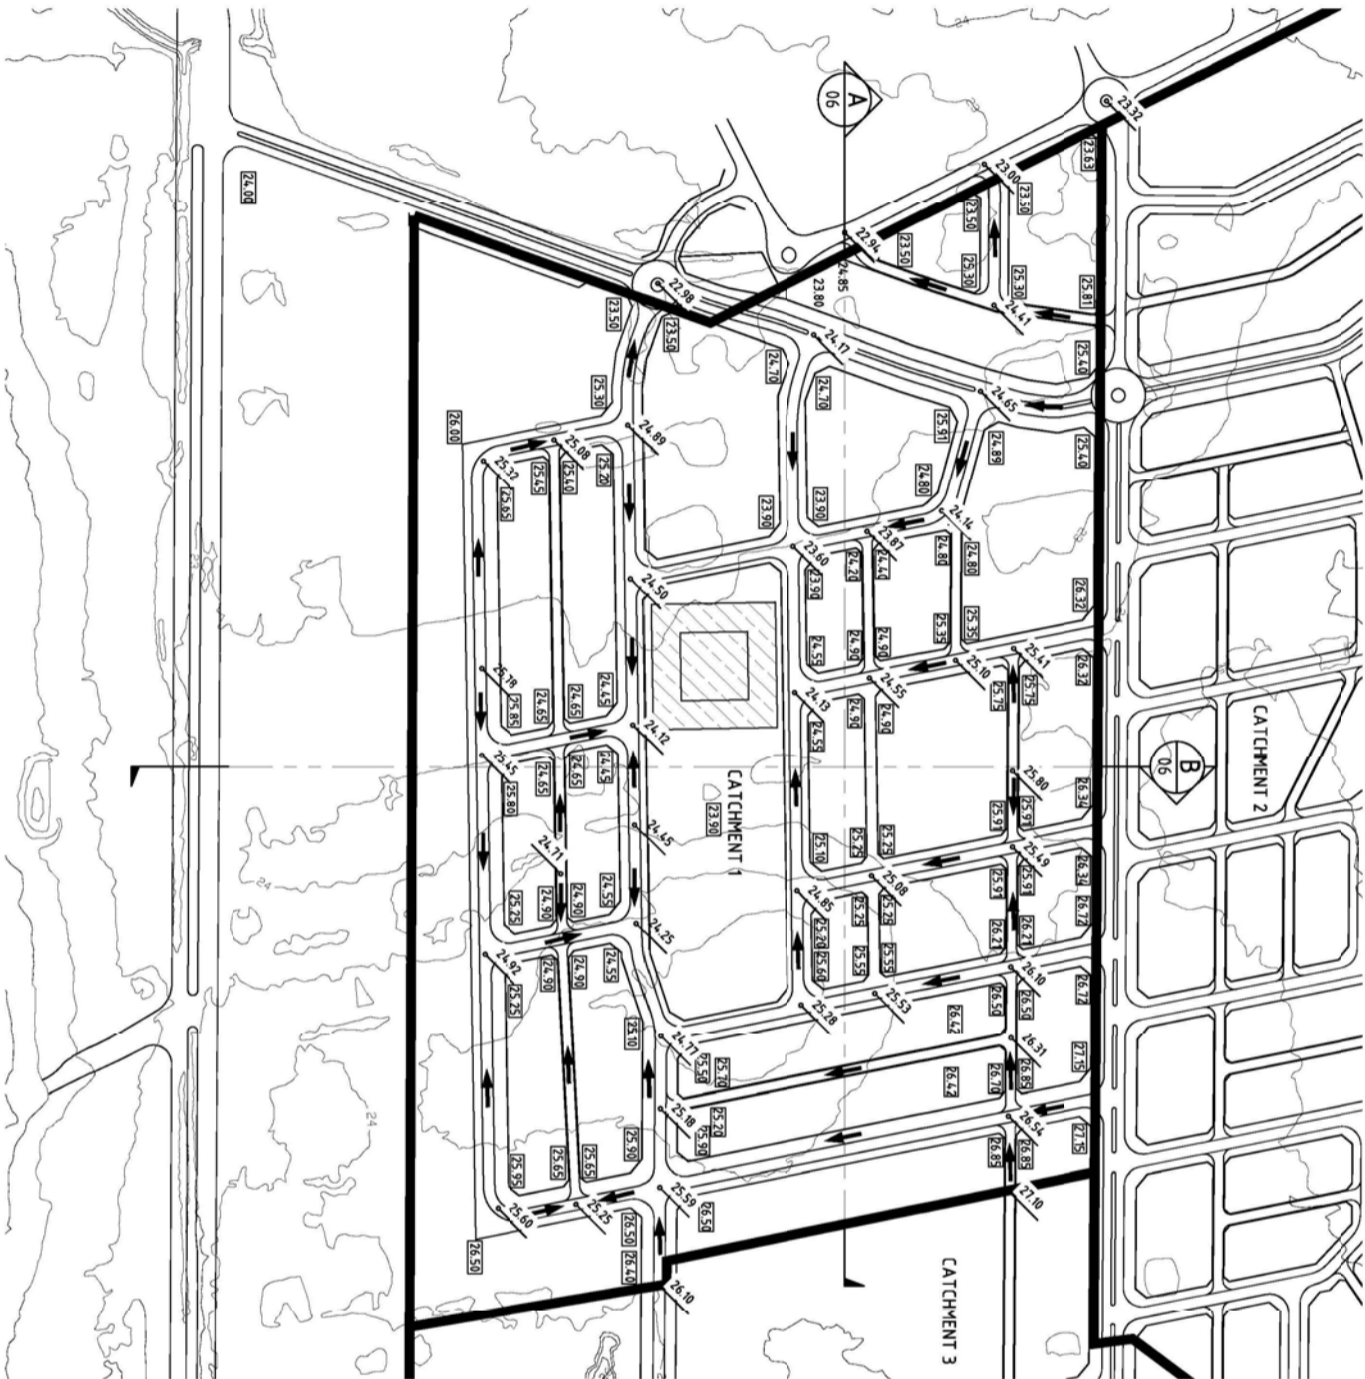
ENGINEERING - DRAINAGE CATCHMENT 1 DESIGN LEVELS
FIGURE 17

<div>ENV AUSTRALIA PTY LTD.</div> <div>MURIEL COURT LUMS COCKBURN CENTRAL</div> <div>DRAINAGE CATCHMENT 1 DESIGN LEVELS</div>										<div>THIS IS ISSUED FOR INFORMATION ONLY. IT IS NOT TO BE USED FOR ANY PURPOSE OTHER THAN THAT INDICATED.</div> <div><input checked="" type="checkbox"/> FOR INFORMATION <input type="checkbox"/> FOR CONSTRUCTION <input type="checkbox"/> FOR TENDER</div>										<div>SCALE: 1:500</div> <div>SHEET SIZE: A1</div> <div>DATE: -</div> <div>ALL DIMENSIONS IN MILLIMETRES DO NOT SCALE</div> <div>  </div>										<div>PROJECT</div> <div>DRAWING NUMBER: 12233-05</div> <div>REVISION: A</div>									
<div>McDowall Affleck</div> <div>DESIGNERS PROJECT MANAGERS CONSTRUCTORS</div> <div>69 Great Northern Hwy Midland Western Australia 6055 PO Box 1377 Midland WA 9336</div> <div>T +61 8 9274 6444 F +61 8 9250 3433 E manager@mada.net.au W www.mcdowallaffleck.com.au</div>										<div>COPYRIGHT OF ALL THIS DRAWING IS RESERVED BY THE CONSULTANT. THIS DRAWING IS TO BE READ IN CONJUNCTION WITH ALL OTHER RELEVANT DRAWING RELATING TO THE PROJECT FOR ACCURATE COORDINATION OF SERVICES. THE CONTRACTOR SHALL BE RESPONSIBLE FOR SITE CHECKING ALL DIMENSIONS BEFORE PREPARATION OF WORKING DRAWINGS OR COMMENCEMENT OF WORK. THIS DRAWING IS THE PROPERTY OF THE CONSULTANT AND SHALL BE RETURNED UPON REQUEST.</div>										<div>INITIAL DRAWING</div> <div>DATE: 15.10.2010</div> <div>DESIGNED: PR</div> <div>DRAWN: JB</div> <div>CHECKED: MD</div>

Bioretention area outflow pipe invert is set at 300mm above the base of the bioretention areas so that all storm water entering the bioretention areas is retained and infiltrated for the 1 year 1 hour ARI event. Each bioretention area has been designed with one 300mm outflow pipe to limit the flow rate from the bioretention area to achieve the 1 in 100 year ARI pre-development.

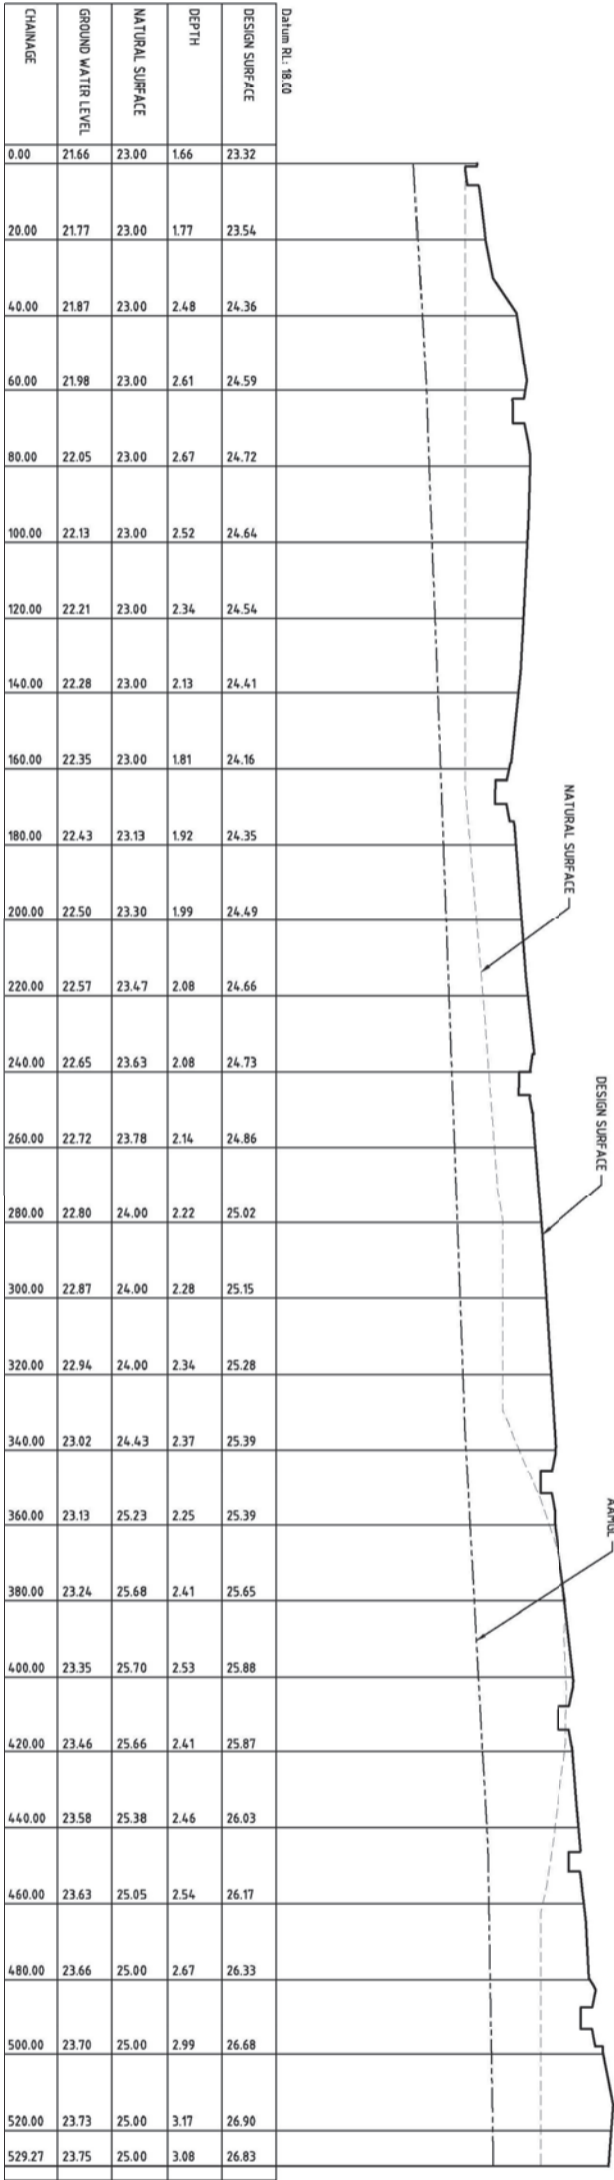
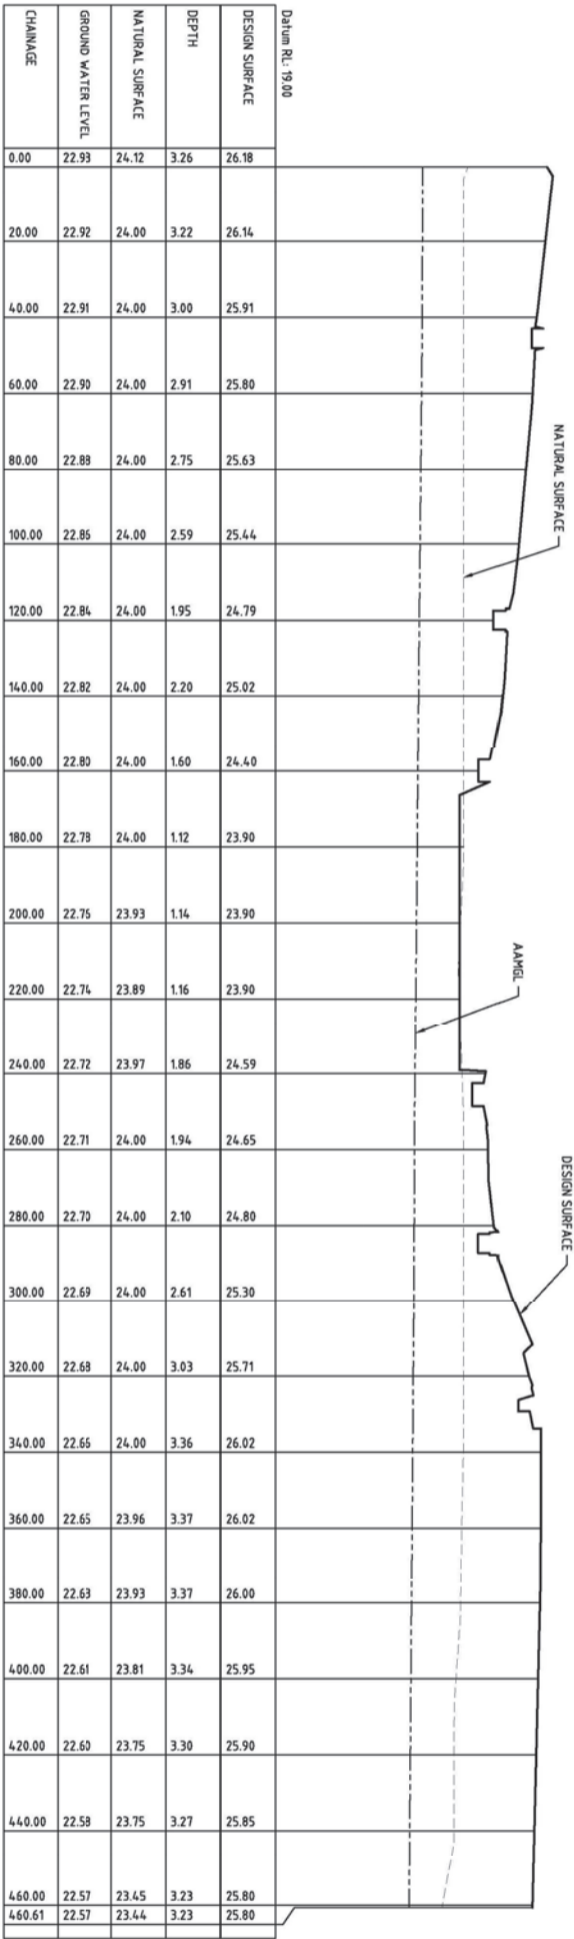
ENGINEERING - DRAINAGE CATCHMENT 1 SECTIONS PLAN
FIGURE 18

SECTION B
H 11000 V 1100
05

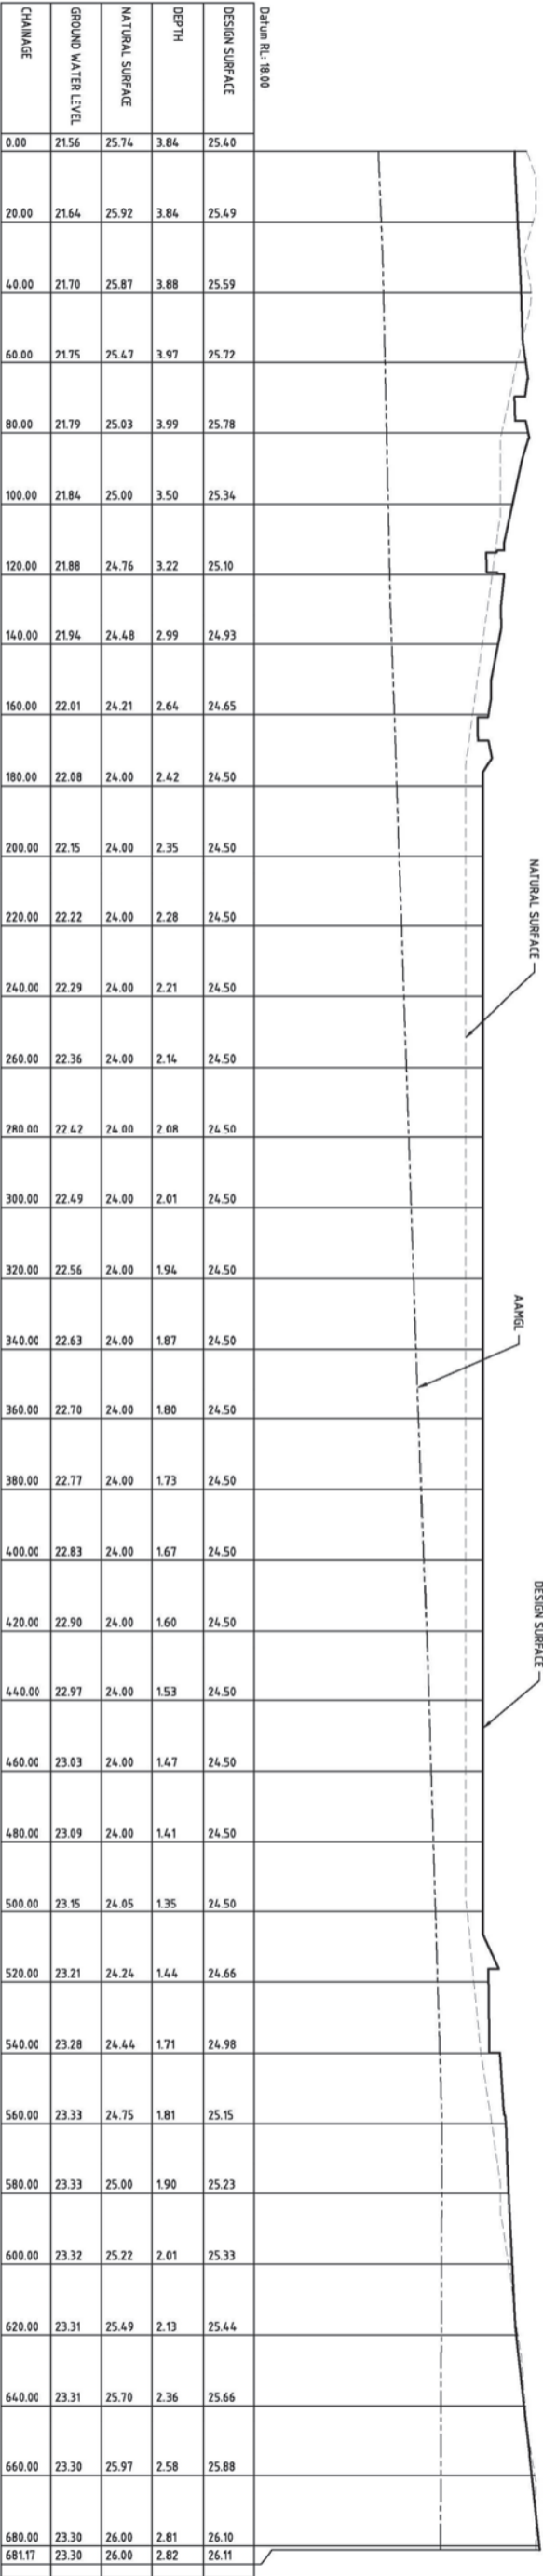
ENGINEERING - DRAINAGE CATCHMENT 2 SECTIONS PLAN 1
FIGURE 20

SECTION D
H 1:1000 V 1:100
07

Datum RL: 19.60				
CHAINAGE	GROUND WATER LEVEL	NATURAL SURFACE	DEPTH	DESIGN SURFACE
0.00	22.33	24.55	2.92	24.85
20.00	22.33	24.03	2.75	25.07
40.00	22.33	24.00	2.97	25.30
60.00	22.32	24.00	3.09	25.41
80.00	22.31	24.00	3.07	25.38
100.00	22.29	24.00	3.04	25.33
120.00	22.28	24.00	2.86	25.14
140.00	22.26	24.00	2.79	25.06
160.00	22.25	24.00	2.42	24.67
180.00	22.24	24.00	2.26	24.50
200.00	22.22	24.00	2.28	24.50
220.00	22.21	24.00	2.29	24.50
240.00	22.19	24.00	2.31	24.50
260.00	22.18	24.00	2.32	24.50
280.00	22.17	24.00	2.37	24.54
300.00	22.15	24.00	2.58	24.73
320.00	22.14	24.00	2.75	24.89
340.00	22.12	24.00	2.95	25.08
360.00	22.11	23.81	3.16	25.27
380.00	22.10	23.30	3.36	25.46
400.00	22.08	23.00	3.56	25.64
420.00	22.07	23.00	3.63	25.70
426.42	22.06	23.00	3.54	25.61

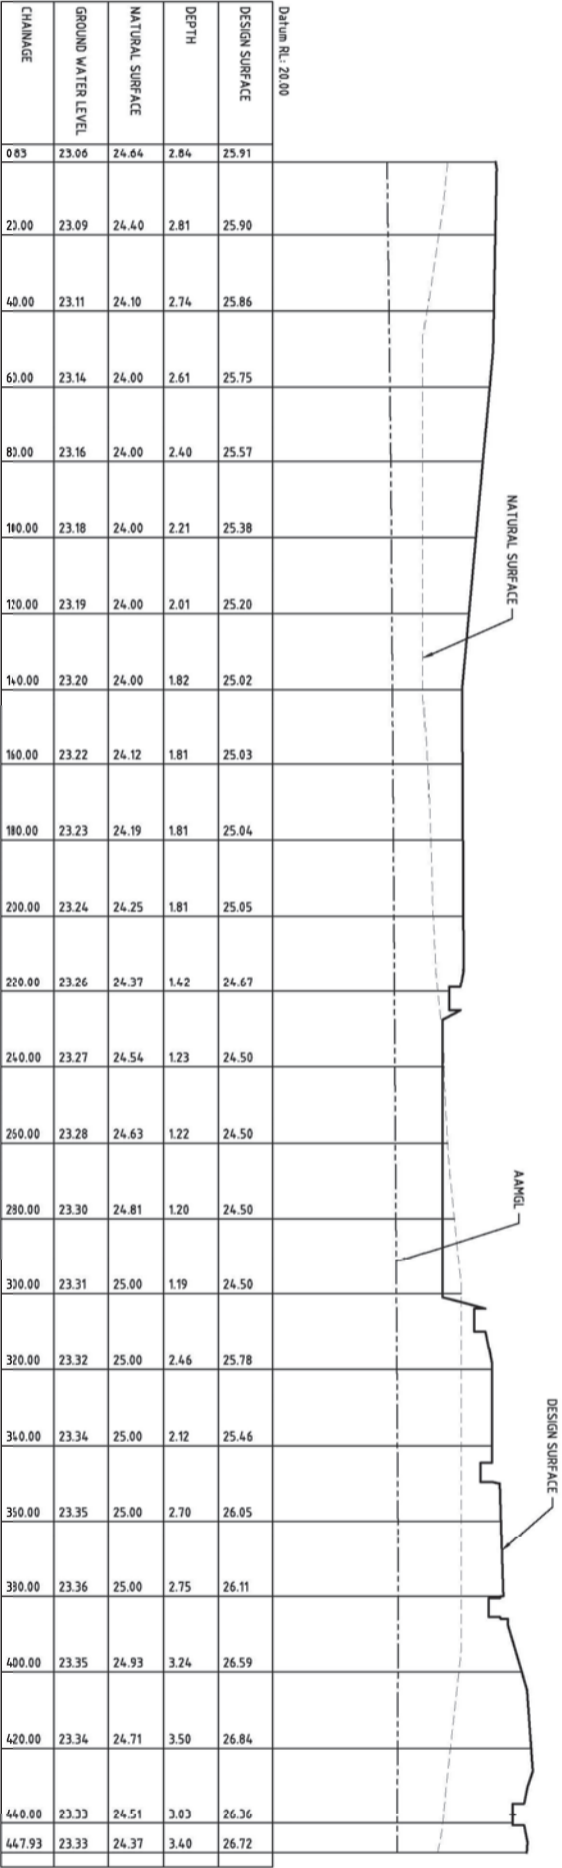
ENGINEERING - DRAINAGE CATCHMENT 2 SECTIONS PLAN 2

SECTION F
H 1:1000 V 1:100
07

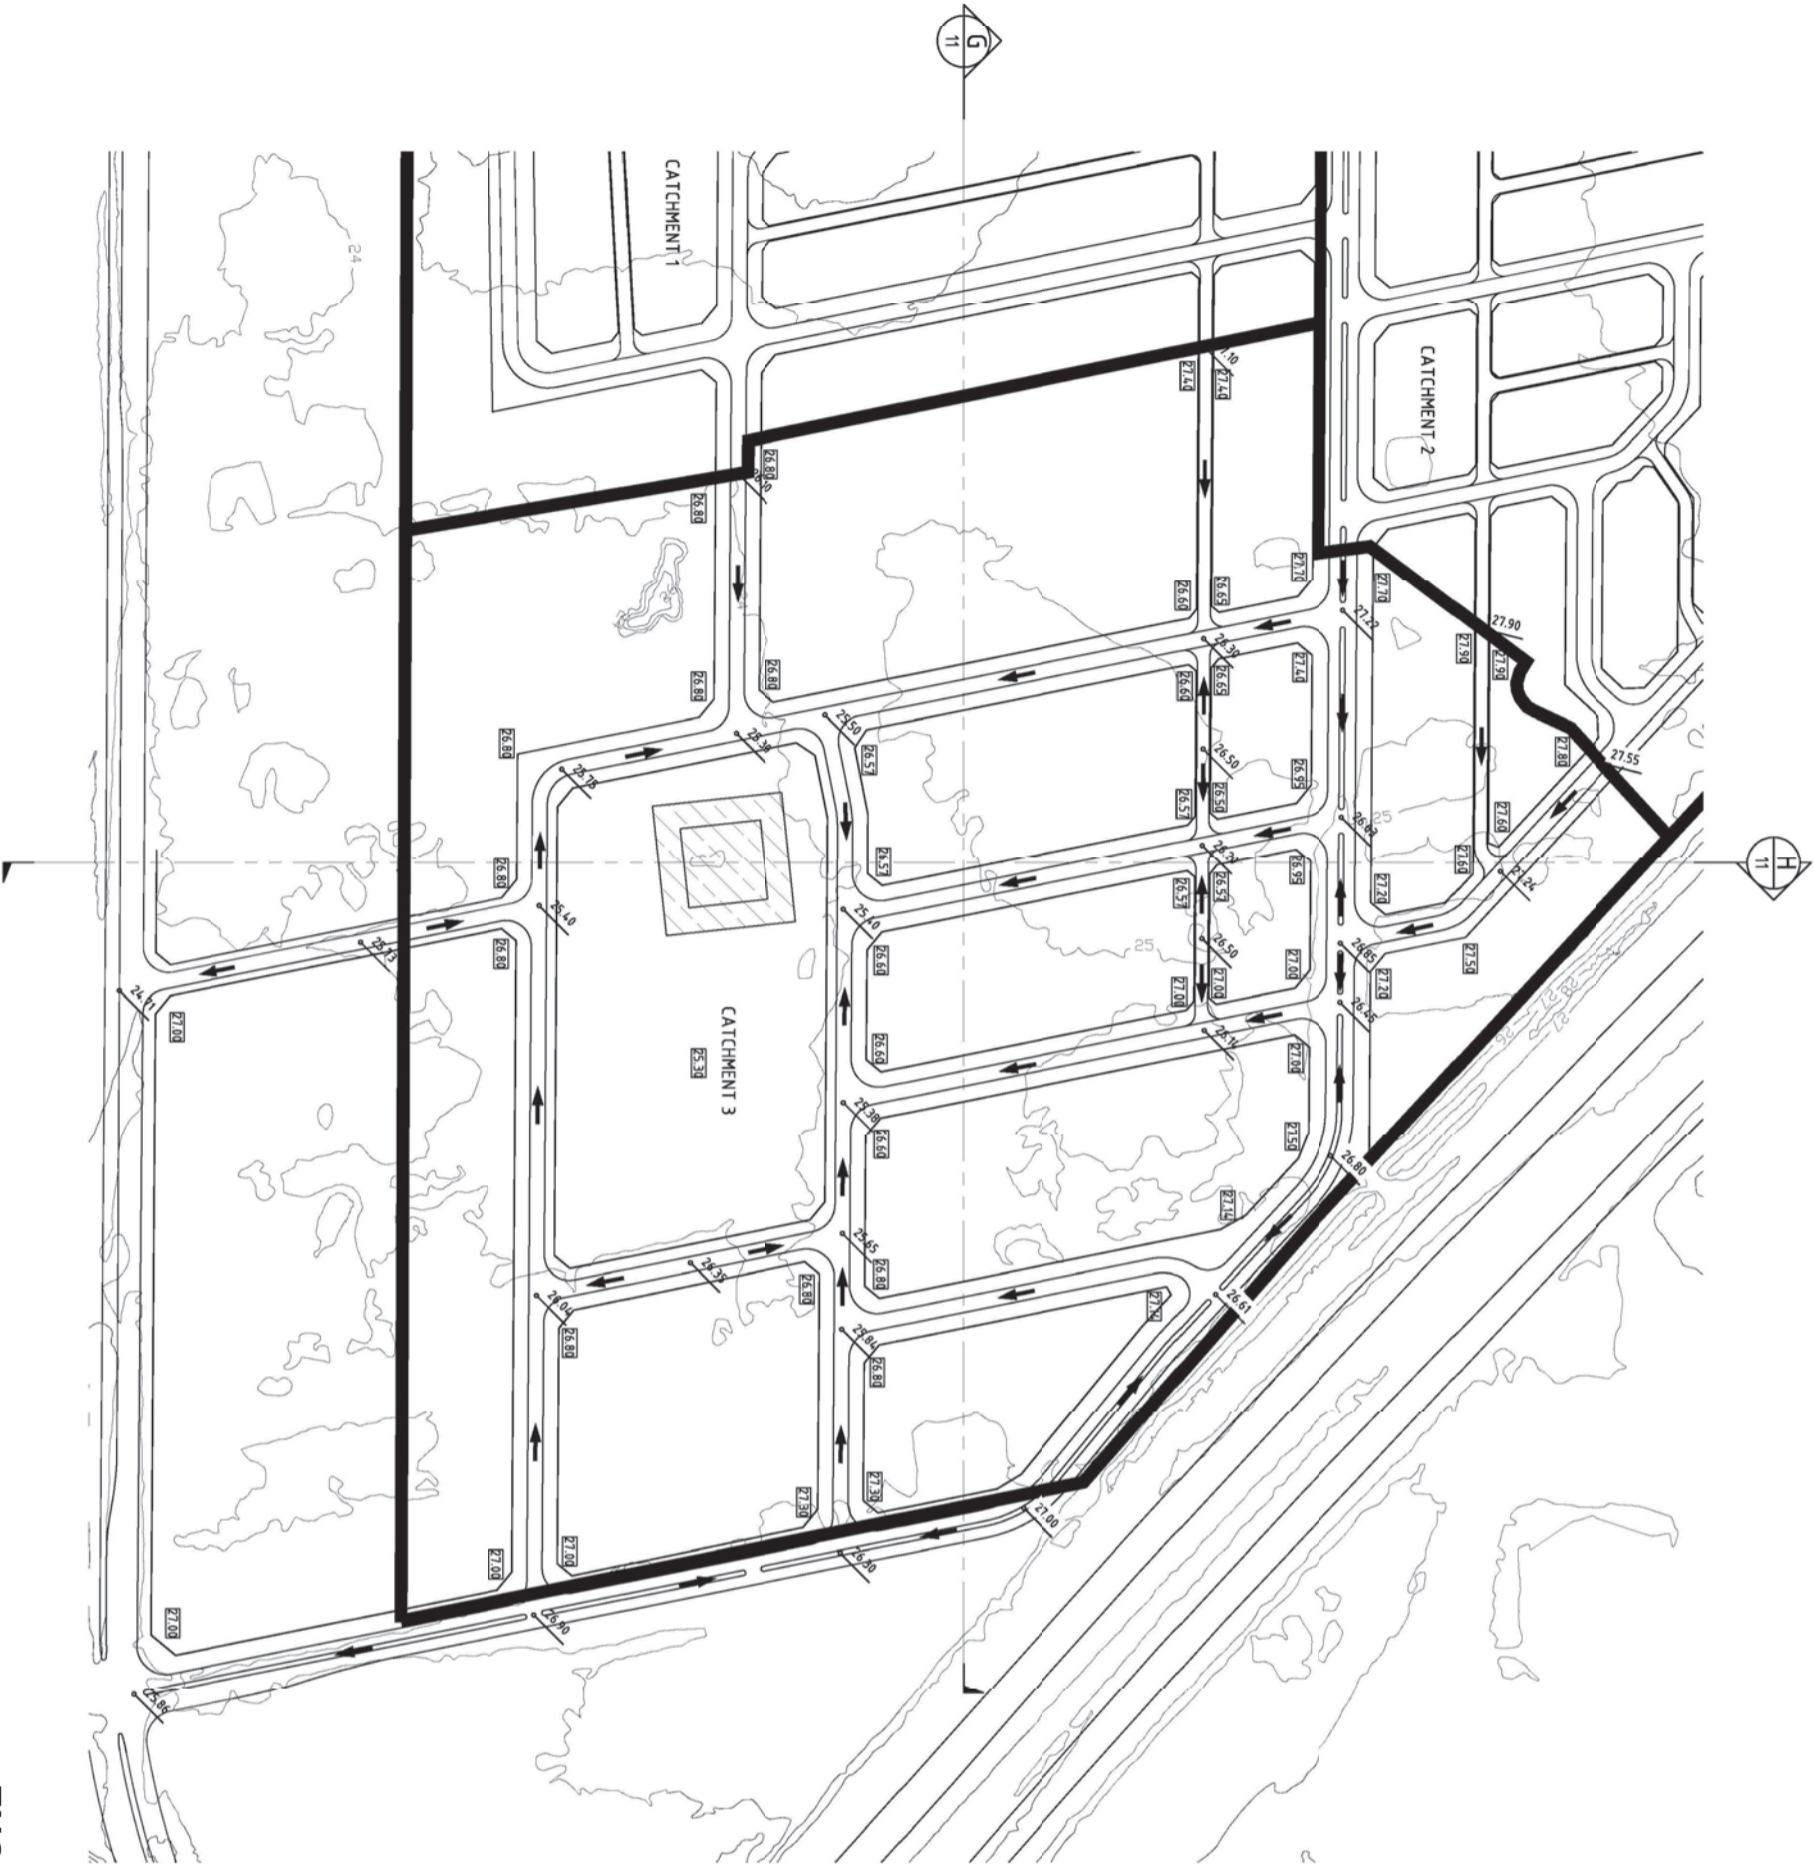
ENGINEERING - DRAINAGE CATCHMENT 3 DESIGN LEVELS
FIGURE 22

SCALE		1:500		SHEET CODE		A1			
PROJECT		 		DRAWING NUMBER		12233-10			
TITLE		MURIEL COURT LUMBS COCKBURN CENTRAL DRAINAGE CATCHMENT 3 DESIGN LEVELS		REVISION		A
