DEVELOPMENT AREA 19 (MURIEL COURT)

LOCAL WATER MANAGEMENT STRATEGY

Job No:	<i>09.181</i>
Report No:	<i>11/123</i>
Prepared by:	<i>John Hunt</i>
Status:	<i>Approved</i>
QA Review:	<i>Paul Zahra</i>
Technical Review:	<i>Karen Lane</i>
Content Review:	<i>Karen Lane</i>
Date:	<i>20 September 2011</i>

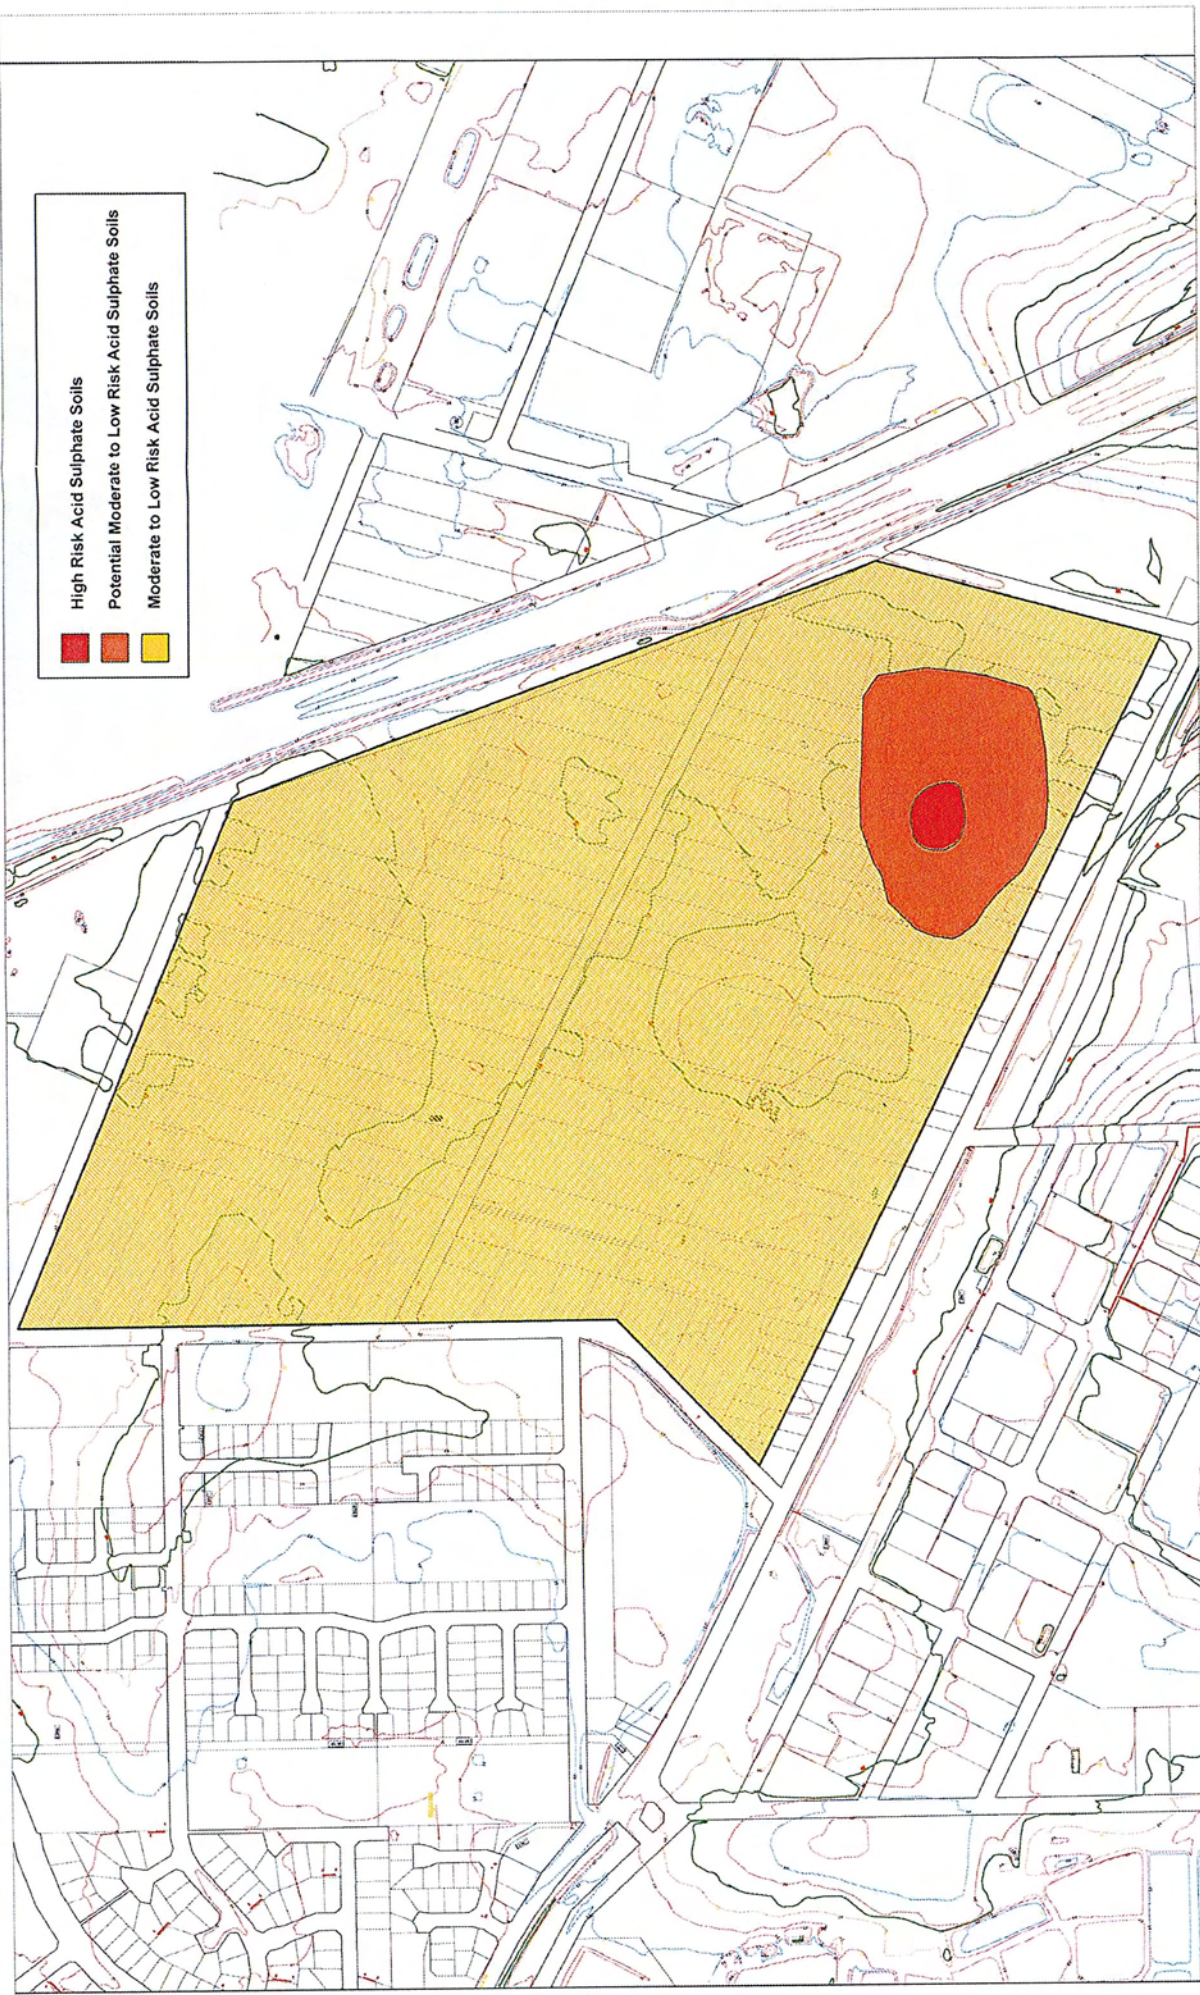
- High Risk Acid Sulphate Soils
- Potential Moderate to Low Risk Acid Sulphate Soils
- Moderate to Low Risk Acid Sulphate Soils

Brown Geotechnical & Environmental			POTENTIAL ACID SULPHATE SOIL ZONES		CLIENT		Drawing No. 07036.03
Suite 4, 47 Monash Avenue			DEVELOPMENT AREA 19 (MURIEL COURT)		KOLTASZ SMITH		Scale: NTS
Como WA 6152			JANDAKOT				Sheet Size: A4
Tel: 08 9368 2615							Job No: J07036.01
Email: bge@acutss.com.au							FIGURE 3
Date	Description	Drawn	Checked	Approved			
10.05.07	Test Location Plan	TW	KB

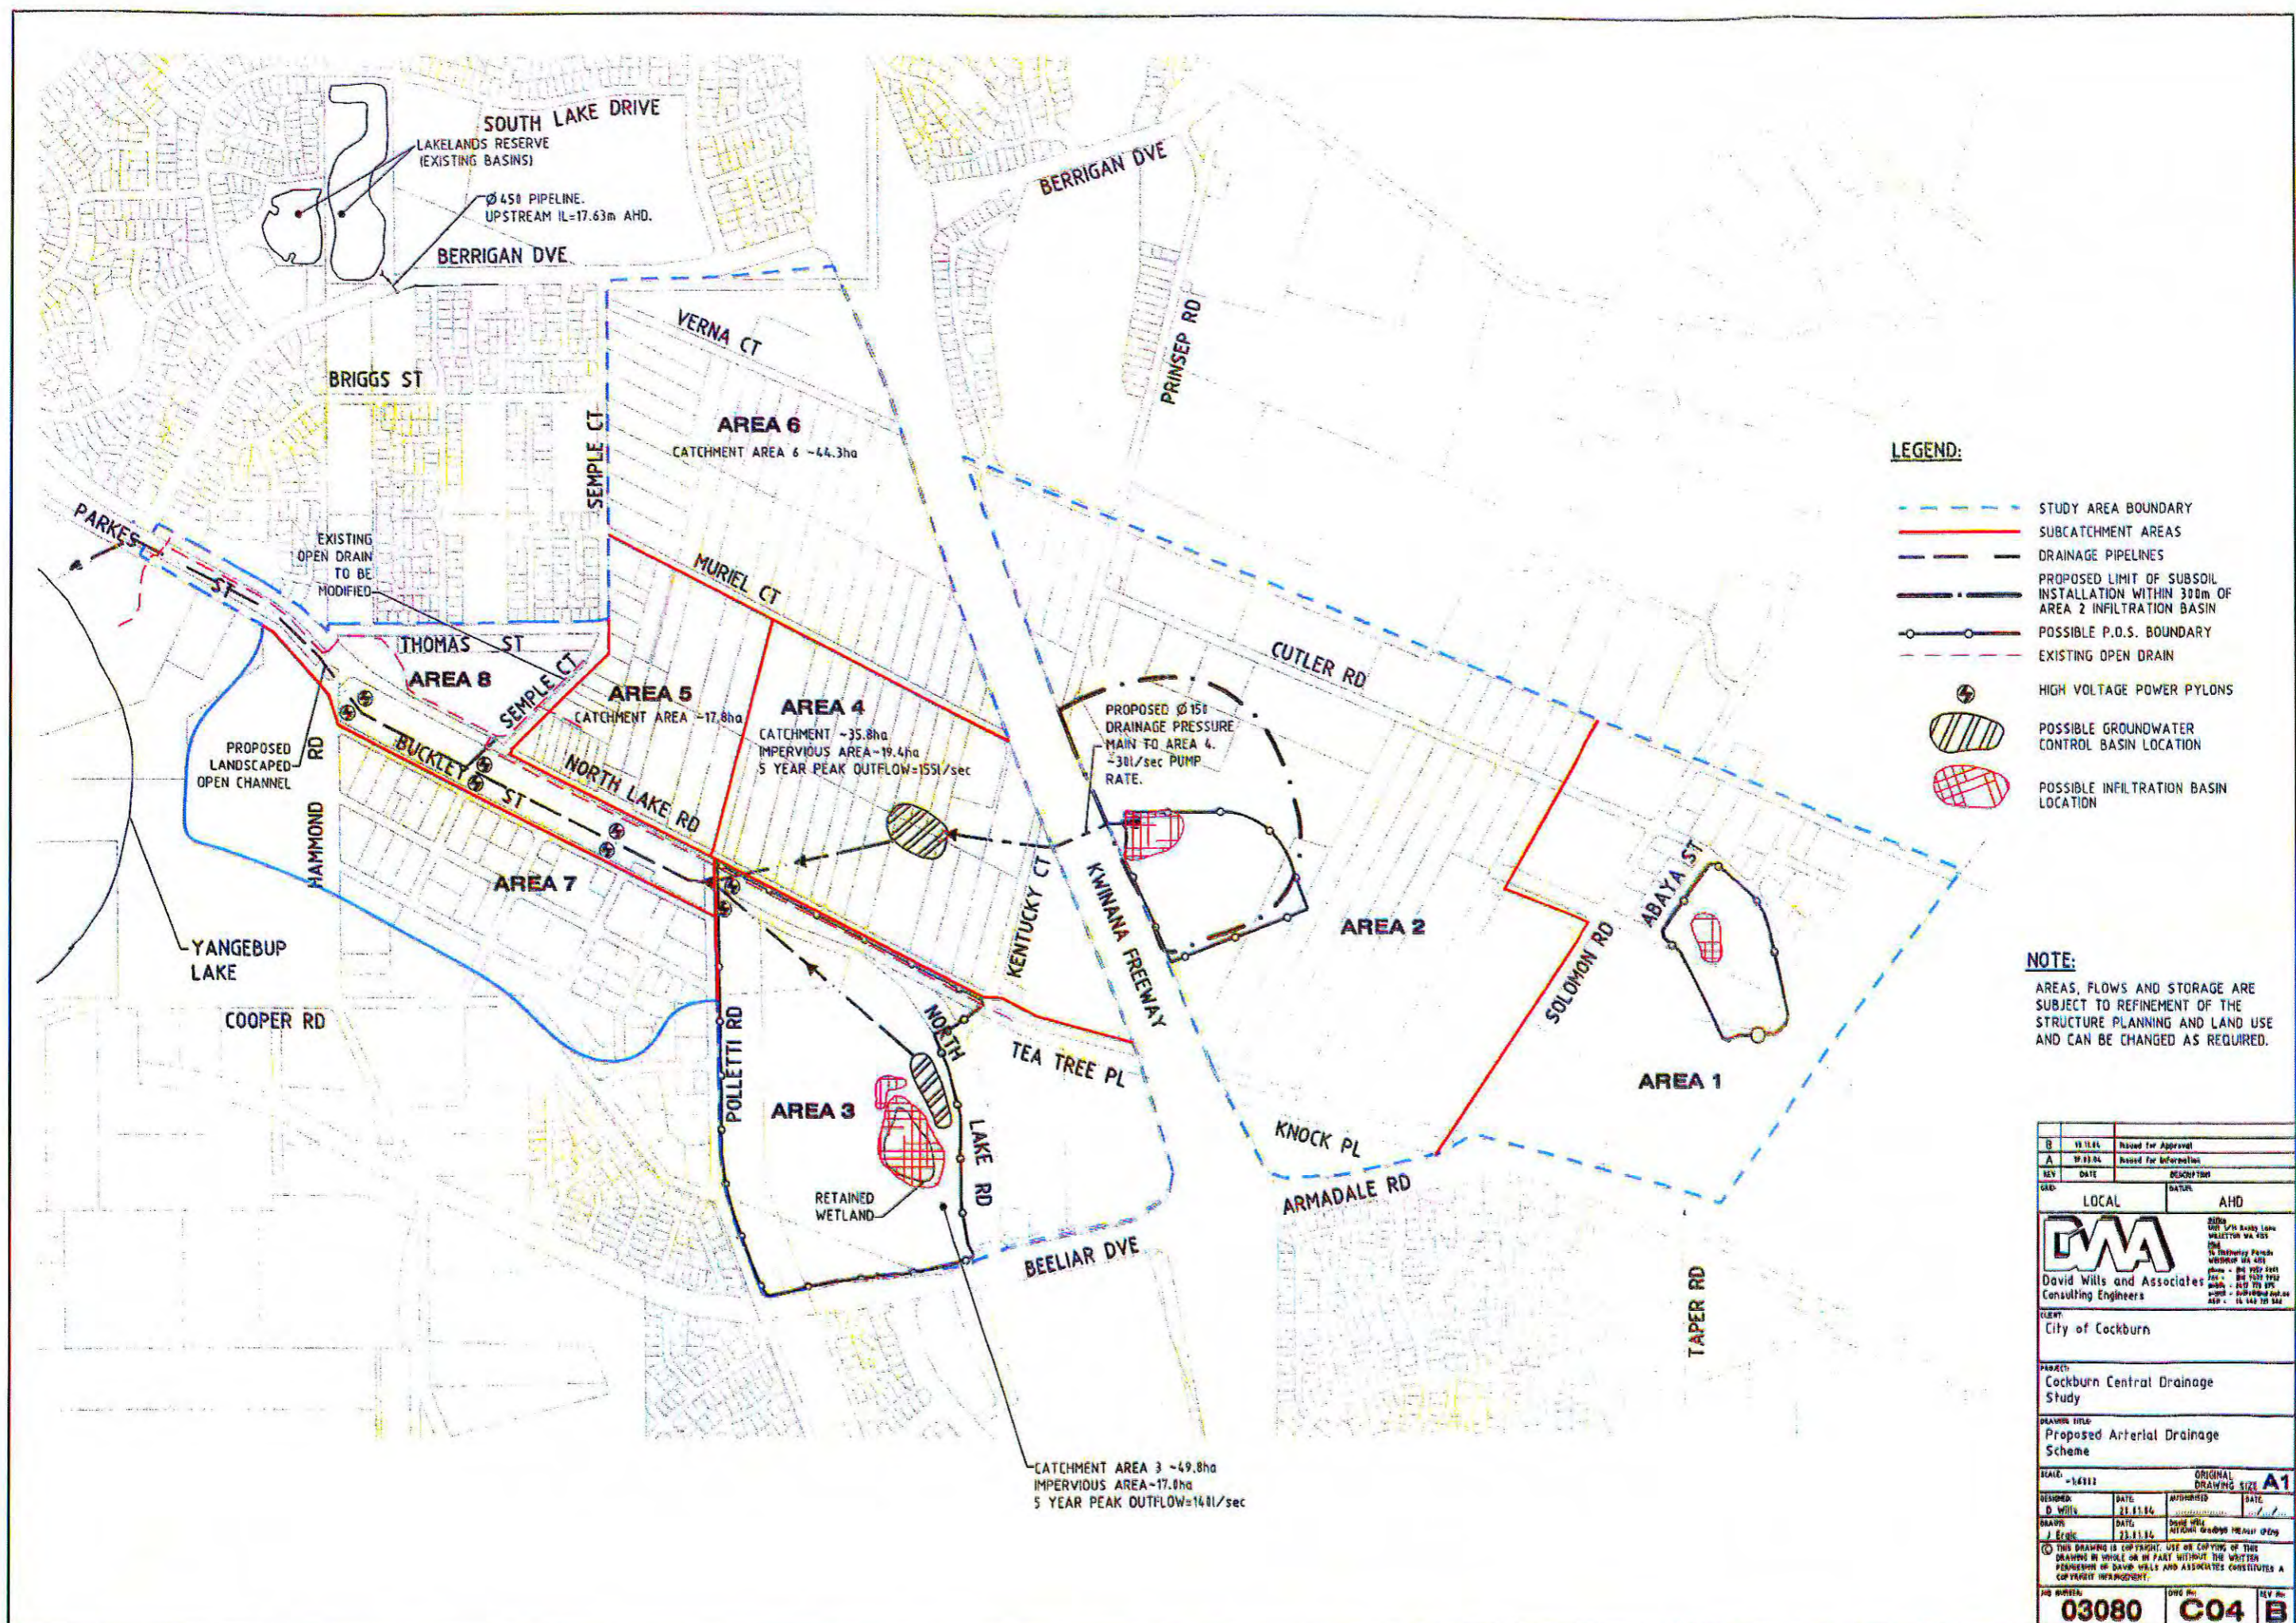
X		DRAWING									
Y		DRAWING									
Z		DRAWING									
AA		DRAWING									
AB		DRAWING									
AC		DRAWING									
AD		DRAWING									
AE		DRAWING									
AF		DRAWING									
AG		DRAWING									
AH		DRAWING									
AI		DRAWING									
AJ		DRAWING									
AK		DRAWING									
AL		DRAWING									
AM		DRAWING									
AN		DRAWING									
AO		DRAWING									
AP		DRAWING									
AQ		DRAWING									
AR		DRAWING									
AS		DRAWING									
AT		DRAWING									
AU		DRAWING									
AV		DRAWING									
AW		DRAWING									
AX		DRAWING									
AY		DRAWING									
AZ		DRAWING									
BA		DRAWING									
BB		DRAWING									
BC		DRAWING									
BD		DRAWING									
BE		DRAWING									
BF		DRAWING									
BG		DRAWING									
BH		DRAWING									
BI		DRAWING									
BJ		DRAWING									
BK		DRAWING									
BL		DRAWING									
BM		DRAWING									
BN		DRAWING									
BO		DRAWING									
BP		DRAWING									
BQ		DRAWING

BR		DRAWING									
BS		DRAWING									
BT		DRAWING									
BU		DRAWING									
BV		DRAWING									
BW		DRAWING									
BX		DRAWING									
BY		DRAWING
