# DAVILAK RUINS ARCHAEOLOGICAL MANAGEMENT STRATEGY MANNING ESTATE, HAMILTON HILL

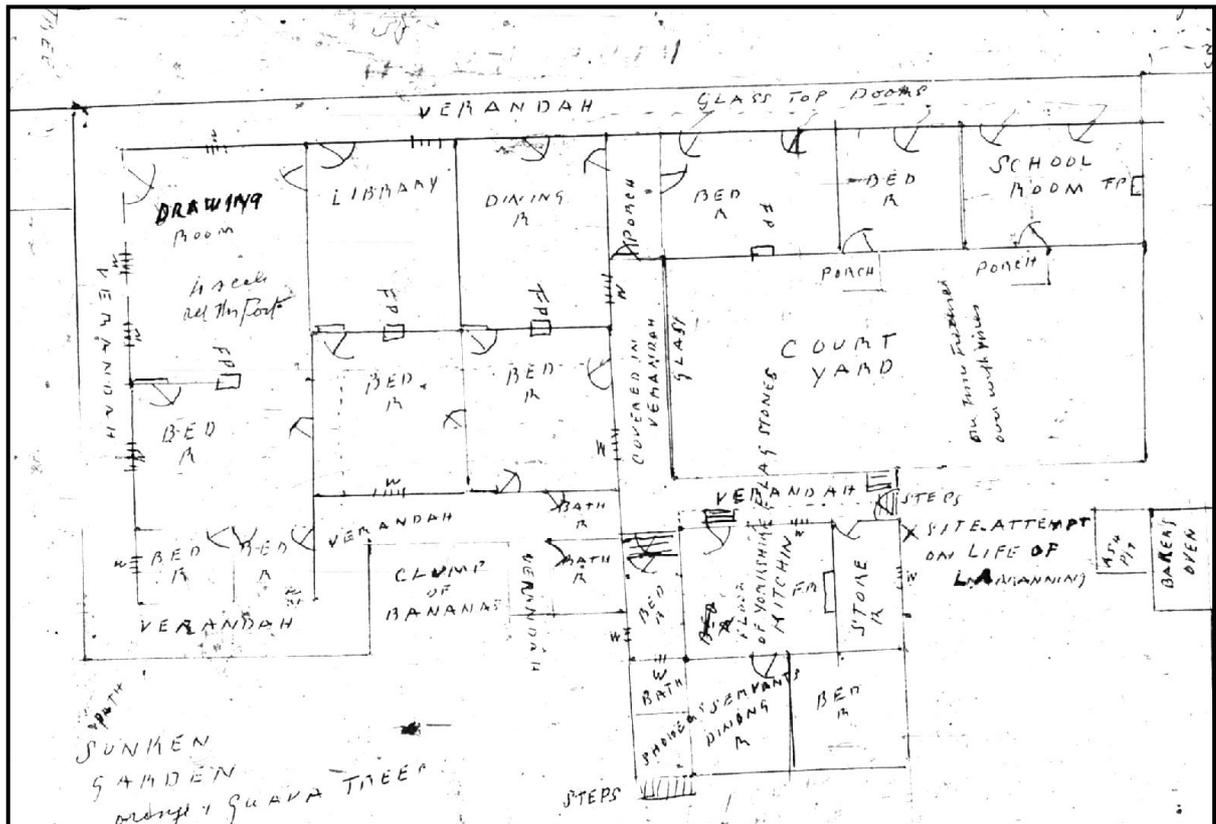
Figure 1 Detail of L.C. Manning's Plan showing layout of the homestead (Courtesy Battye Library)

As discussed in the documentary section, it would appear that the Davilak Homestead began as a small cottage. This is corroborated with physical evidence. Manning's plan (see Figure 1) shows a rectangular building with its long axis running north-south. According to this plan, verandahs ran around all sides of the building, with the exception of the southern side. The various rooms in the building comprise three distinct suites of rooms. The largest suite is the wing at the northern end of the building. This wing contains a drawing room on the east side, with three bedrooms on the west. The next suite lies on the southern side of the drawing room and contains four rooms: library, dining room and (on their western sides), two bedrooms. The final suite is on the southern side of these four rooms. It is separated from the second suite by a covered passage way (possibly a breezeway, the plan does not make this clear). The last suite is a row of three rooms that open onto the eastern verandah: two bedrooms with a schoolroom at the southern end. On the western side of this suite is a courtyard and to the west of the courtyard is the detached kitchen. The kitchen building had seven rooms that included the kitchen, storeroom and accommodation for servants. On the northern side of the detached kitchen two bathrooms are shown.

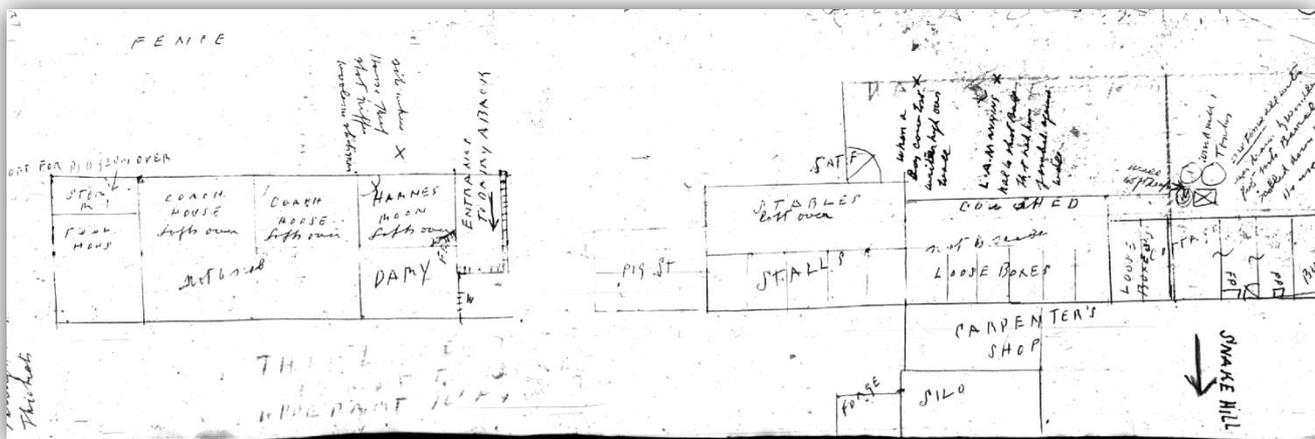
Figure 2 Detail of L.C. Manning's Plan showing farm buildings. Battye Library

The farm buildings lie to the west of the homestead. In the 1965 aerial photograph the line of these buildings is clearly seen, running slightly to the west of a north-south alignment. Manning's map indicates that these buildings once functioned as a coach house (with a loft above) containing accommodation for hens and a harness room with a dairy at the rear of this room. There was then a rather large building that contained stables with a loft over it, stalls at the rear and a cowshed with loose boxes at the back. On the western side of the cowshed was a carpenter's shop, silo and forge. Butting onto this complex was a row of three cottages. A pigsty was located at the northern end of this long building. Fenced yards were located on the eastern side of the building.

The remains today are dominated by what was once the western (rear) wall of this complex that stands above 2 metres in places. This long building (approximately 39 metres) still retains evidence of the different spaces that were shown in Manning's plan such as the stables at the northern end, the cow shed in the centre and the area where the looseboxes would have been located at the southern end (evidence of the timber partitioning may still be found below ground level). It is a large open space heavily overgrown with vegetation with loose stones beneath.

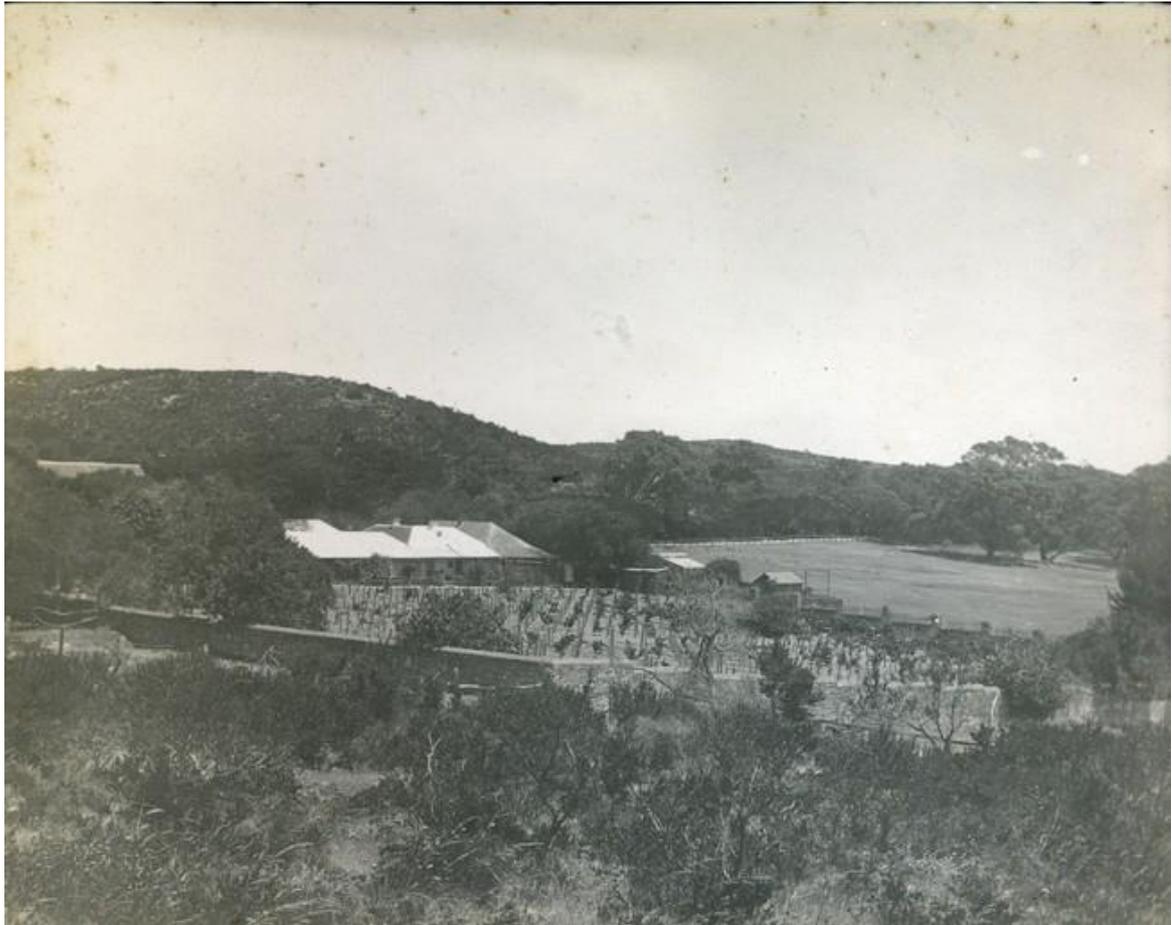
**Plate 1** View of the vineyard and the eastern side of Davilak Homestead c.1900 (Courtesy City of Cockburn Library)

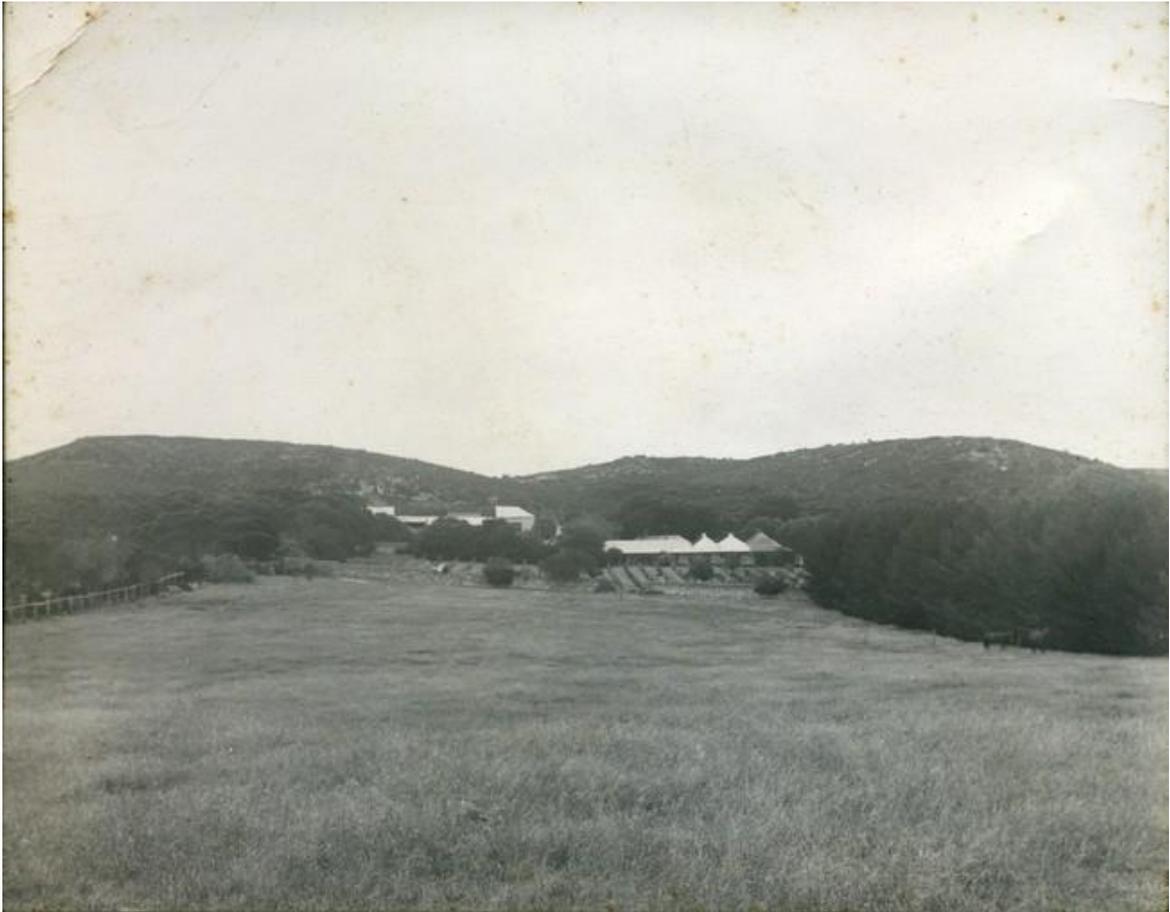
**Plate 2** View looking west across paddocks towards Davilak. The long line of the homestead can be seen on the right and beyond, to the left are the farm buildings. The line of vines can be clearly seen in front of the homestead. (Courtesy City of Cockburn Library).
